City of Palo Alto Water System Pipe Replacement

*Prepared for:
City of Palo Alto*

*G&E Engineering Systems Inc.
6315 Swainland Rd
Oakland, CA 94611
(510) 595-9453 eidinger@geEngineeringSystems.com*

*G&E Report 119.01.02, Revision 0
July 21, 2015*

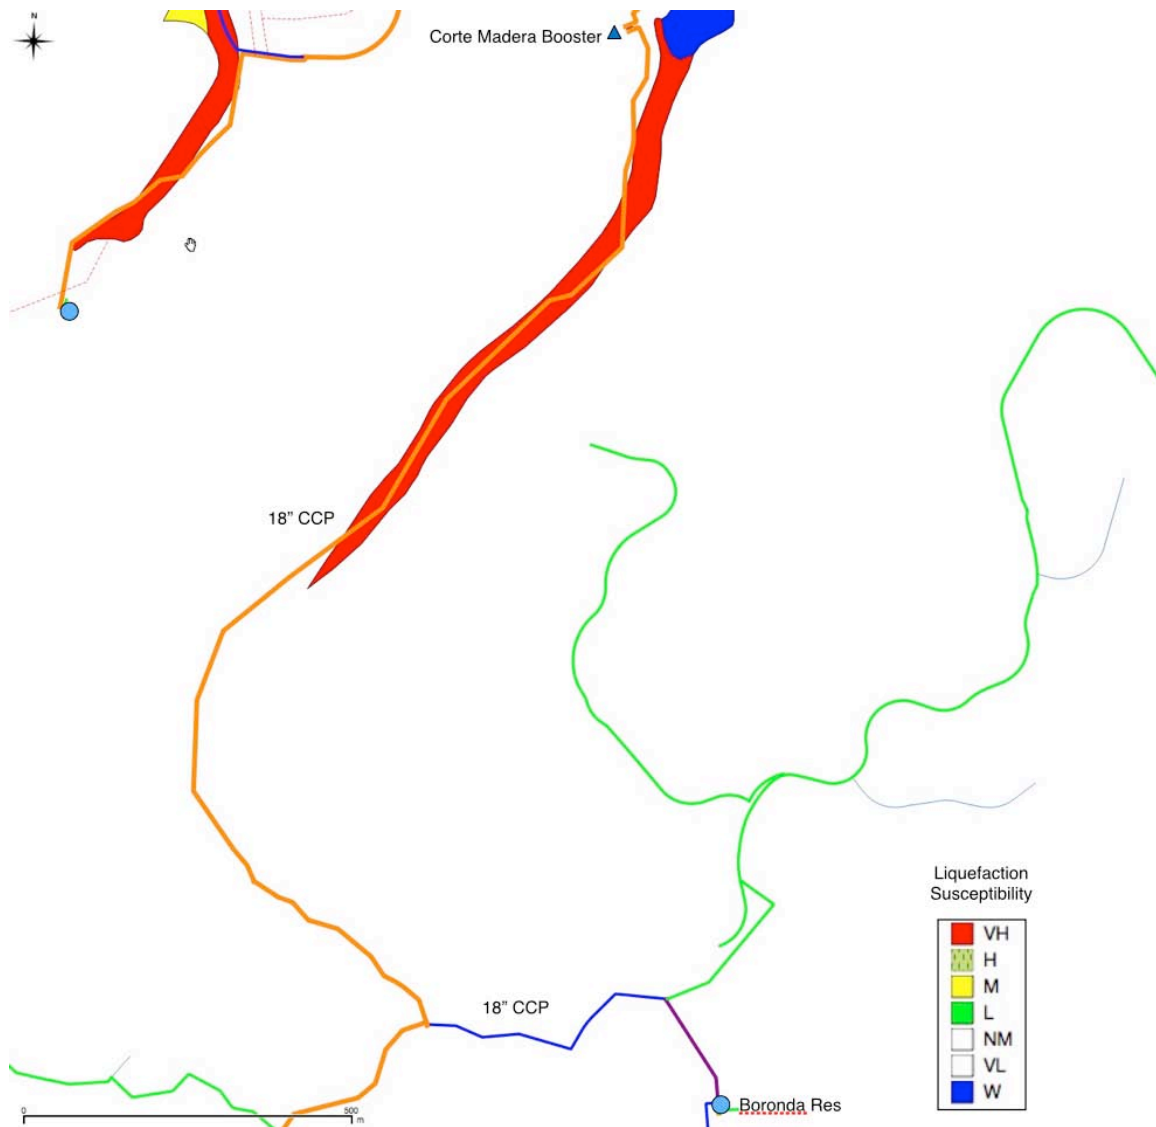
Figure 3-22. Corte Madera to Boronda Reservoir Area – Pipes and Liquefaction Hazard Zones

The interpretation of the "Very High" zones adjacent to the 18" CCP is addressed in Section 5. From the pipe drawings, it appears that this creek is only a few feet deep. For most of the length near the red zone, the pipe is on the west side of the creek. The primary hazard is that the pipe, buried in a slope above the creek, could be dragged towards the creek due to a lateral spread / landslide. This is further discussed in Section 5.

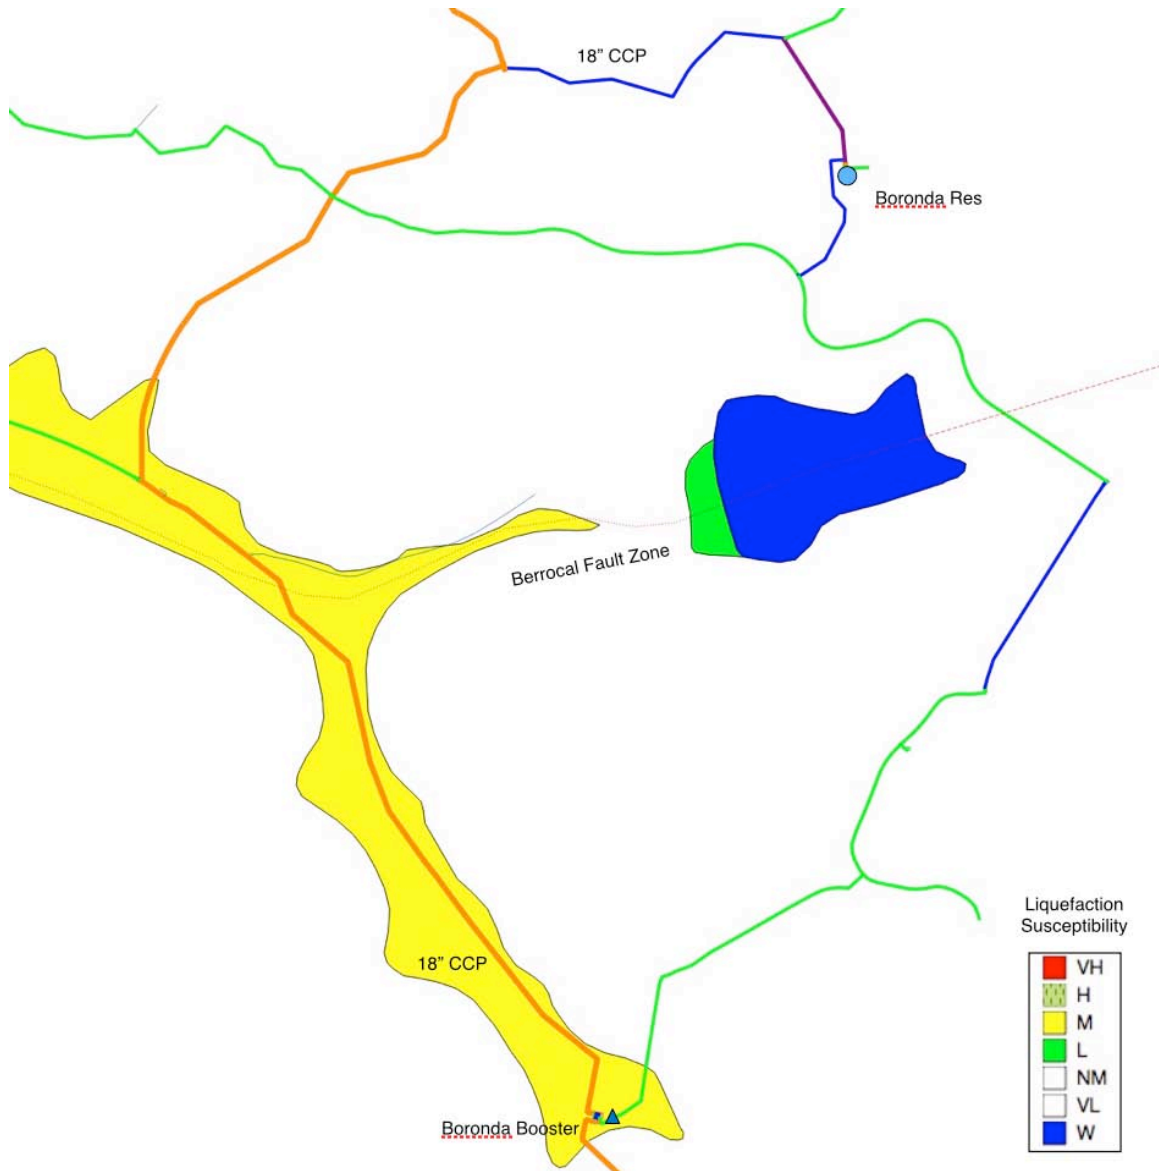
Figure 3-25. Boronda Reservoir to Boronda Booster Area – Pipes, Liquefaction and Fault Hazard Zones

The 18" CCP traverses the Berrocal Fault Zone, as indicated in Figure 3-25.

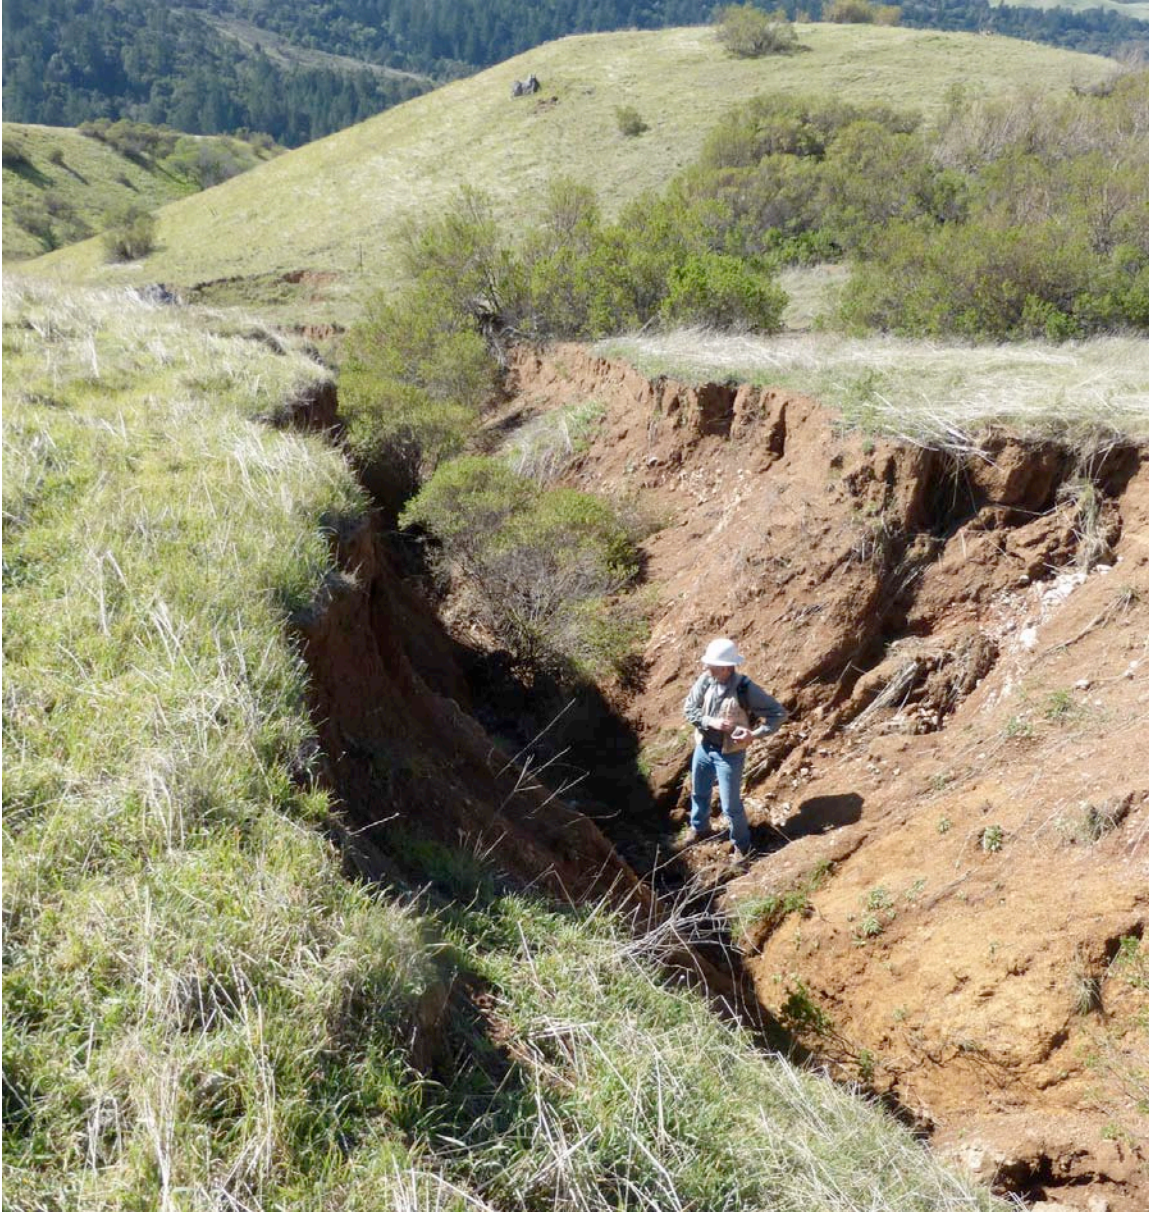
Figure 5-5. Gully, looking north and away from the reservoir, with Dickenson

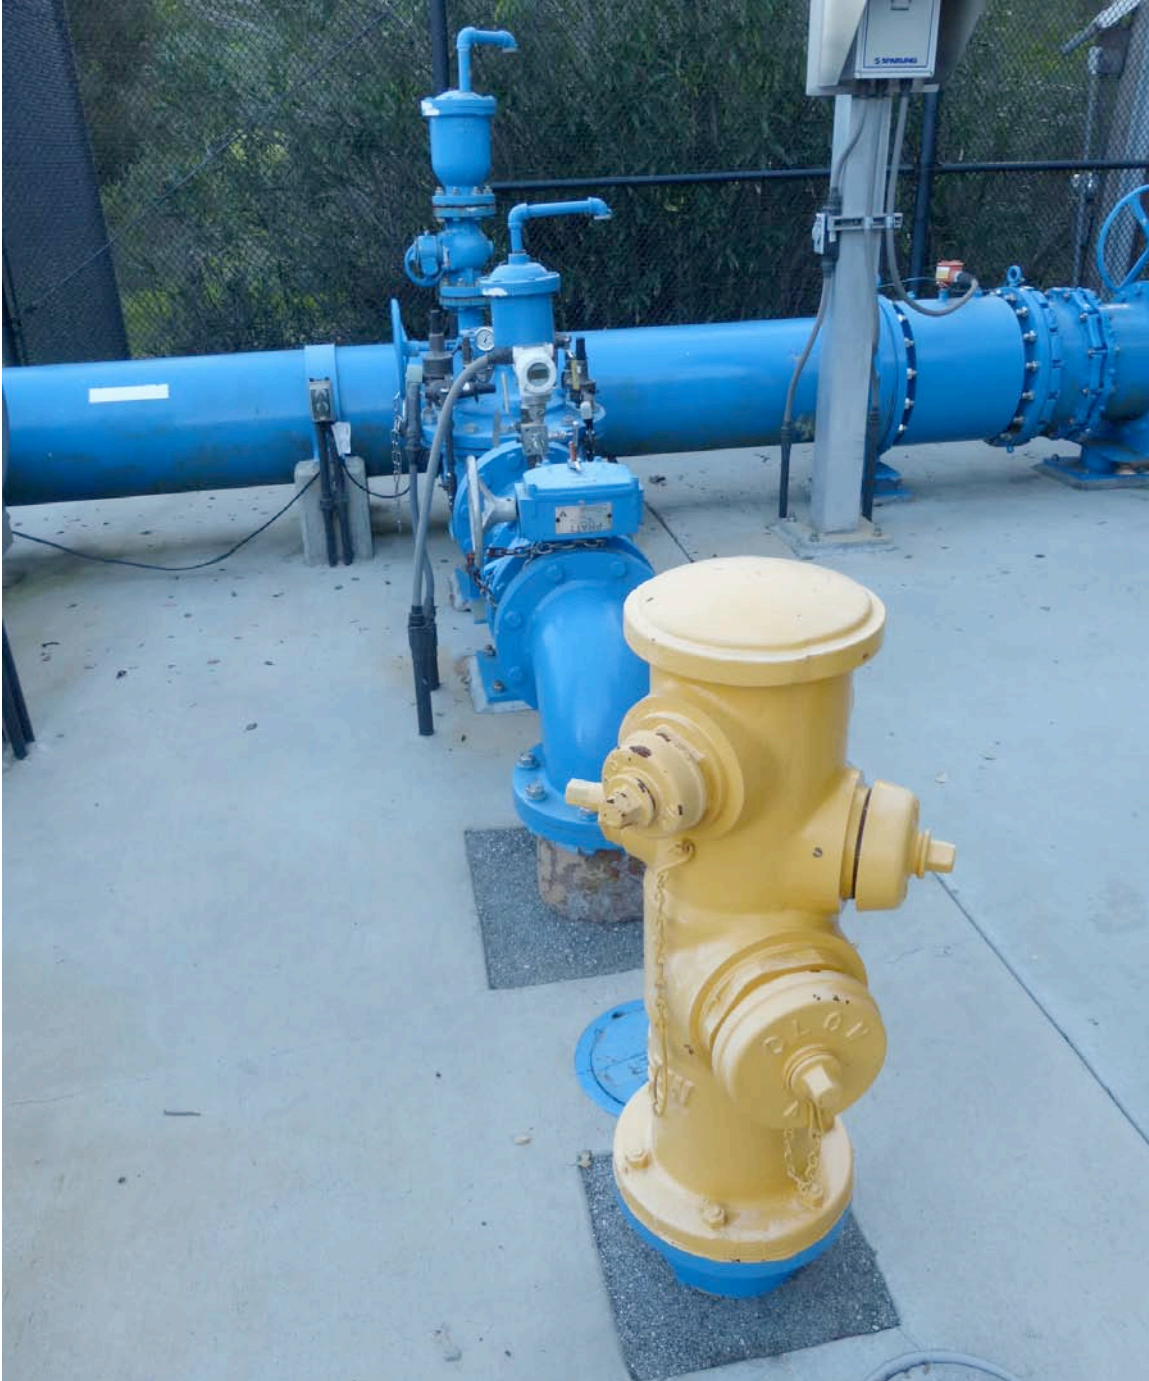
Figure 5-16. Pipes at Quarry Booster Pump Station. Asphalt-filled cut-outs in concrete pads.

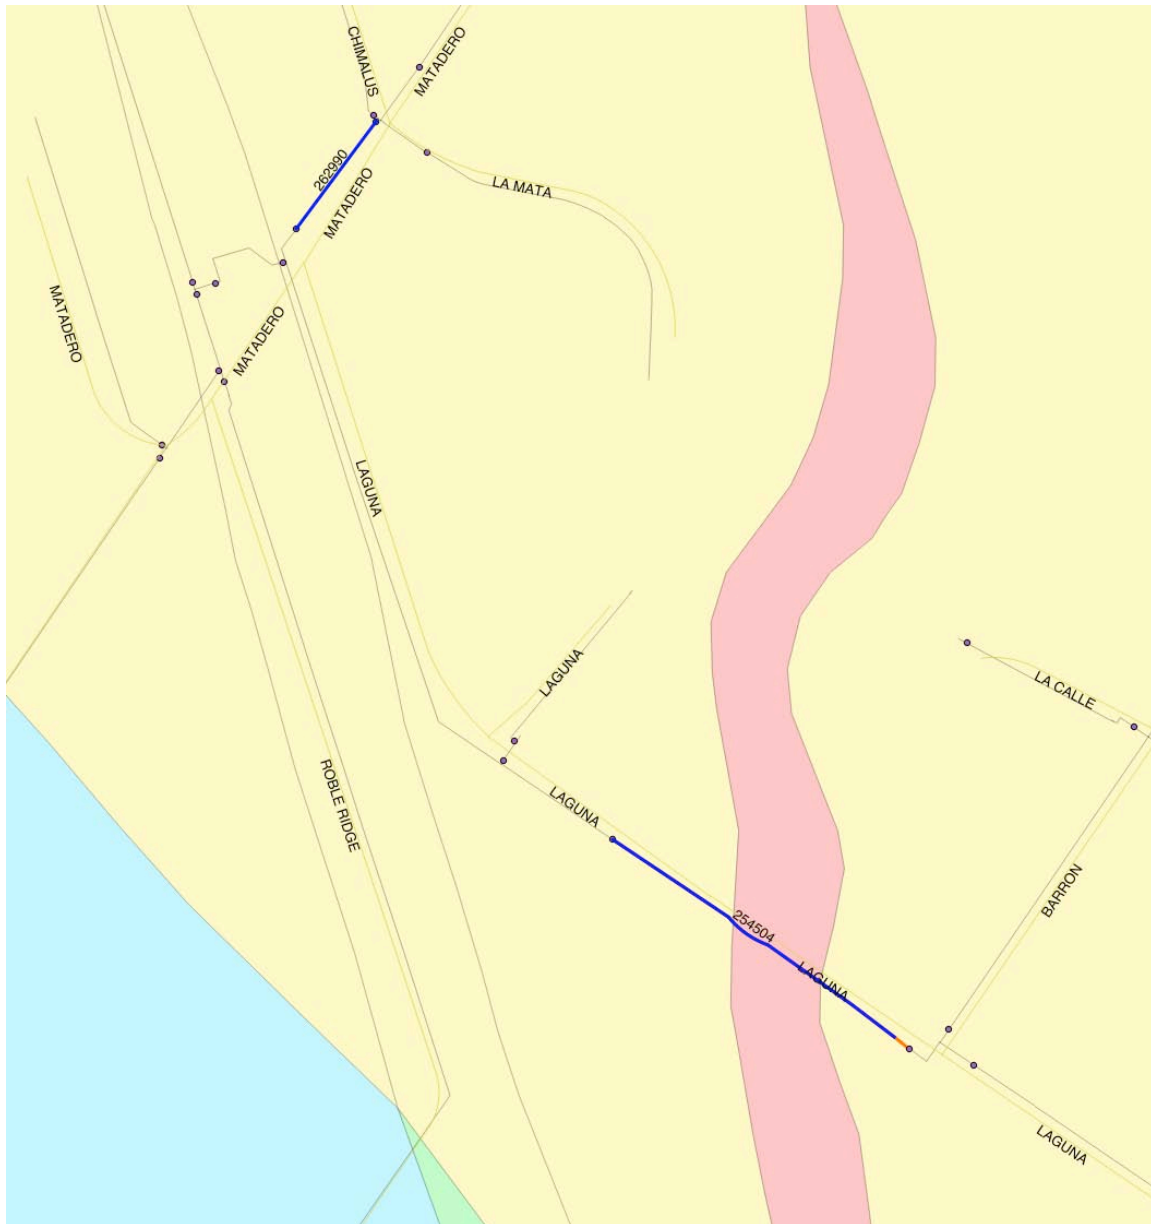
Figure 7-11. AIP Projects 8 and 25 – Laguna and Matadero Replacements

Note; the orange line to the southeast along Laguna (Project 8) reflects a recommended extension of the pipe replacement to reflect seismic issues (to provide adequate anchor zone for liquefaction loading); see Section 7.4 for further details.

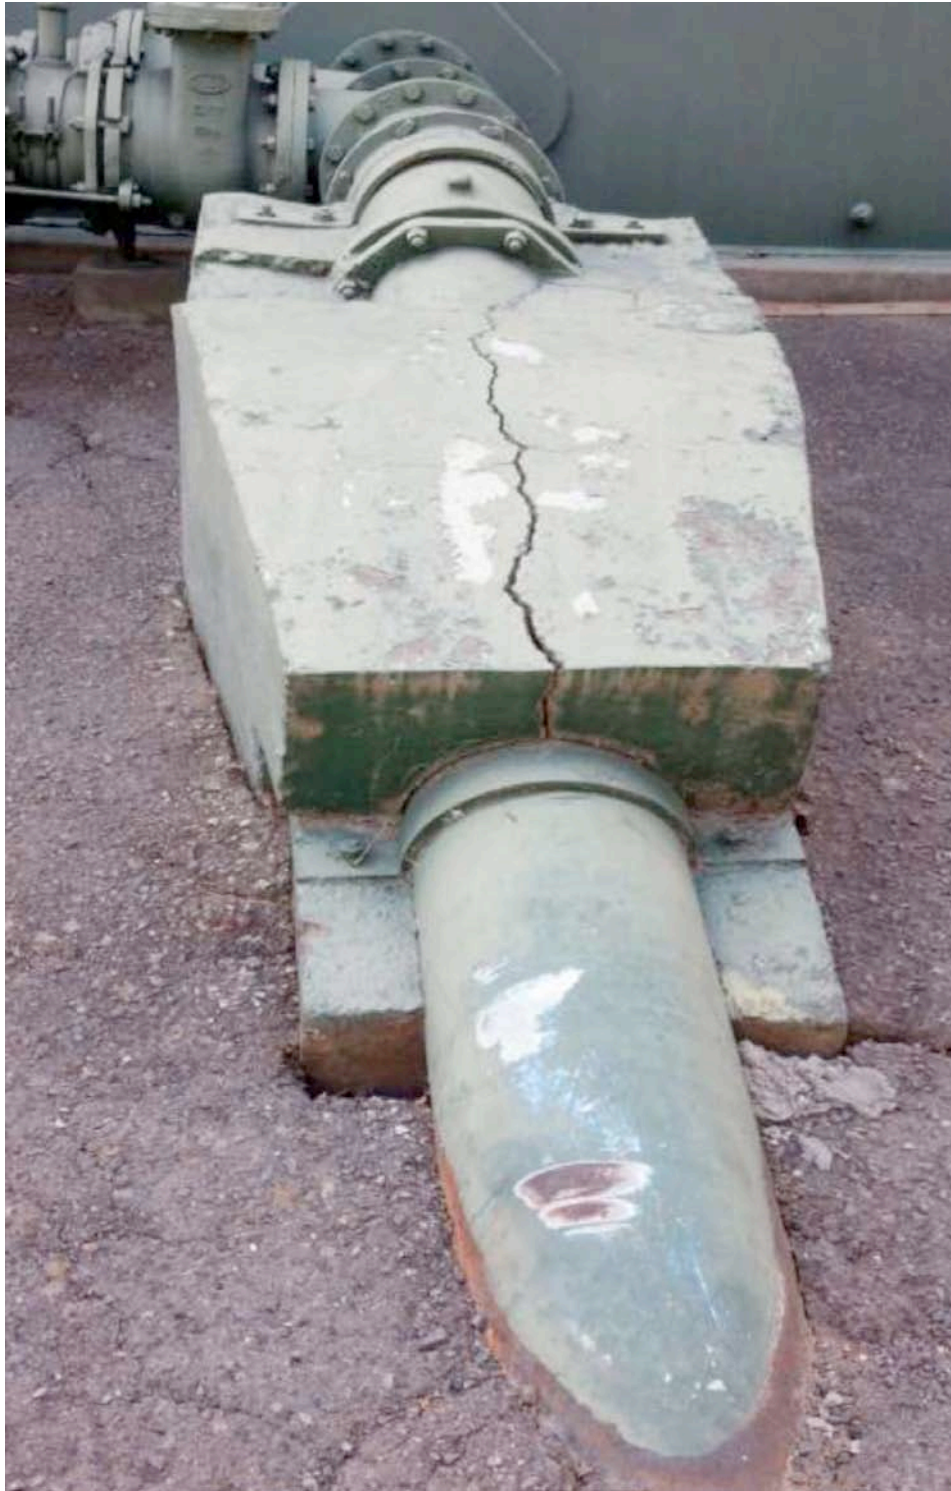
Figure B-28. Tank B. Inlet Outlet Pipes, Cracked Concrete Thrust Block
