4518 Lawler Rd, Garland, TX 75042

Report: 70492578

Total Roof Area =2,223 sq ft  
Total Roof Facets =6  
Predominant Pitch =4/12  
Number of Stories <=1  
Total Ridges/Hips =74 ft  
Total Valleys =39 ft  
Total Rakes =112 ft  
Total Eaves =107 ft  
Estimated Attic=2,128 sq ft

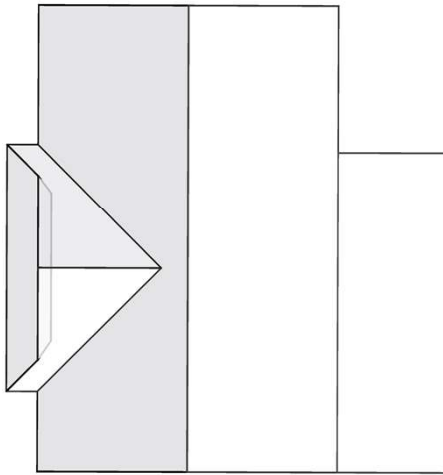
In this 3D model, facets appear as semi-transparent to reveal overhangs.

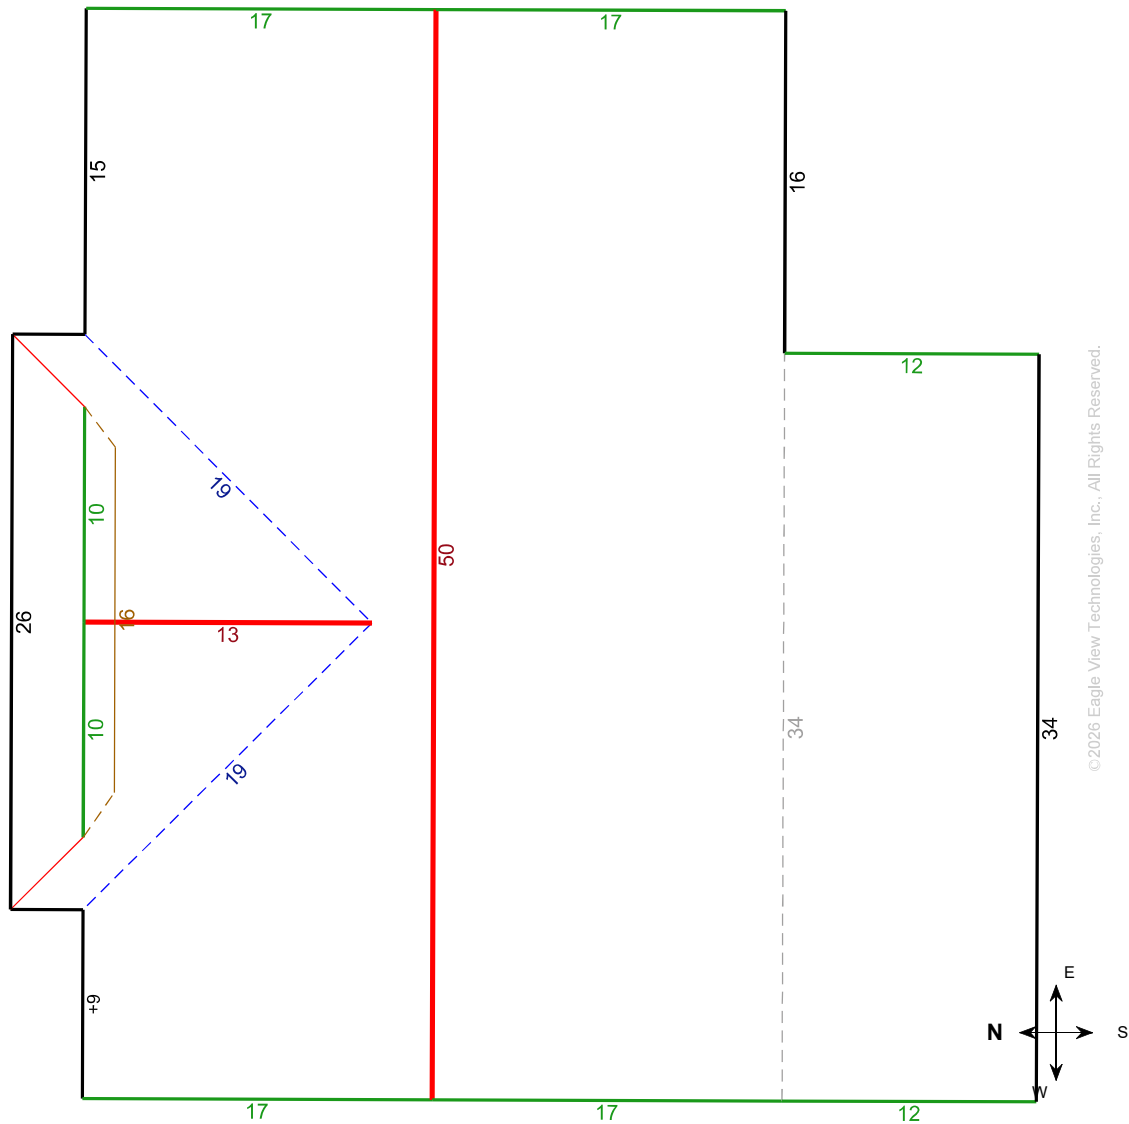
## LENGTH DIAGRAM

Total Line Lengths:

**Ridges = 64 ft**

**Hips = 10 ft**

**Valleys = 39 ft**

**Rakes = 112 ft**

**Eaves = 107 ft**

**Flashing = 16 ft**

**Step flashing = 5 ft**

**Parapets = 0 ft**

**Note:** This diagram contains segment lengths (rounded to the nearest whole number) over 5.0 Feet. In some cases, segment labels have been removed for readability. Plus signs preface some numbers to avoid confusion when rotated (e.g. +6 and +9).

Ridges = 64 ft (2 Ridges)  
 Hips = 10 ft (2 Hips)  
 Valleys = 39 ft (2 Valleys)  
 Rakes<sup>†</sup> = 112 ft (8 Rakes)  
 Eaves/Starter<sup>‡</sup> = 107 ft (7 Eaves)  
 Drip Edge (Eaves + Rakes) = 219 ft (15 Lengths)  
 Parapet Walls = 0 (0 Lengths)  
 Flashing = 16 ft (1 Lengths)  
 Step flashing = 5 ft (2 Lengths)  
 Predominant Pitch = 4/12

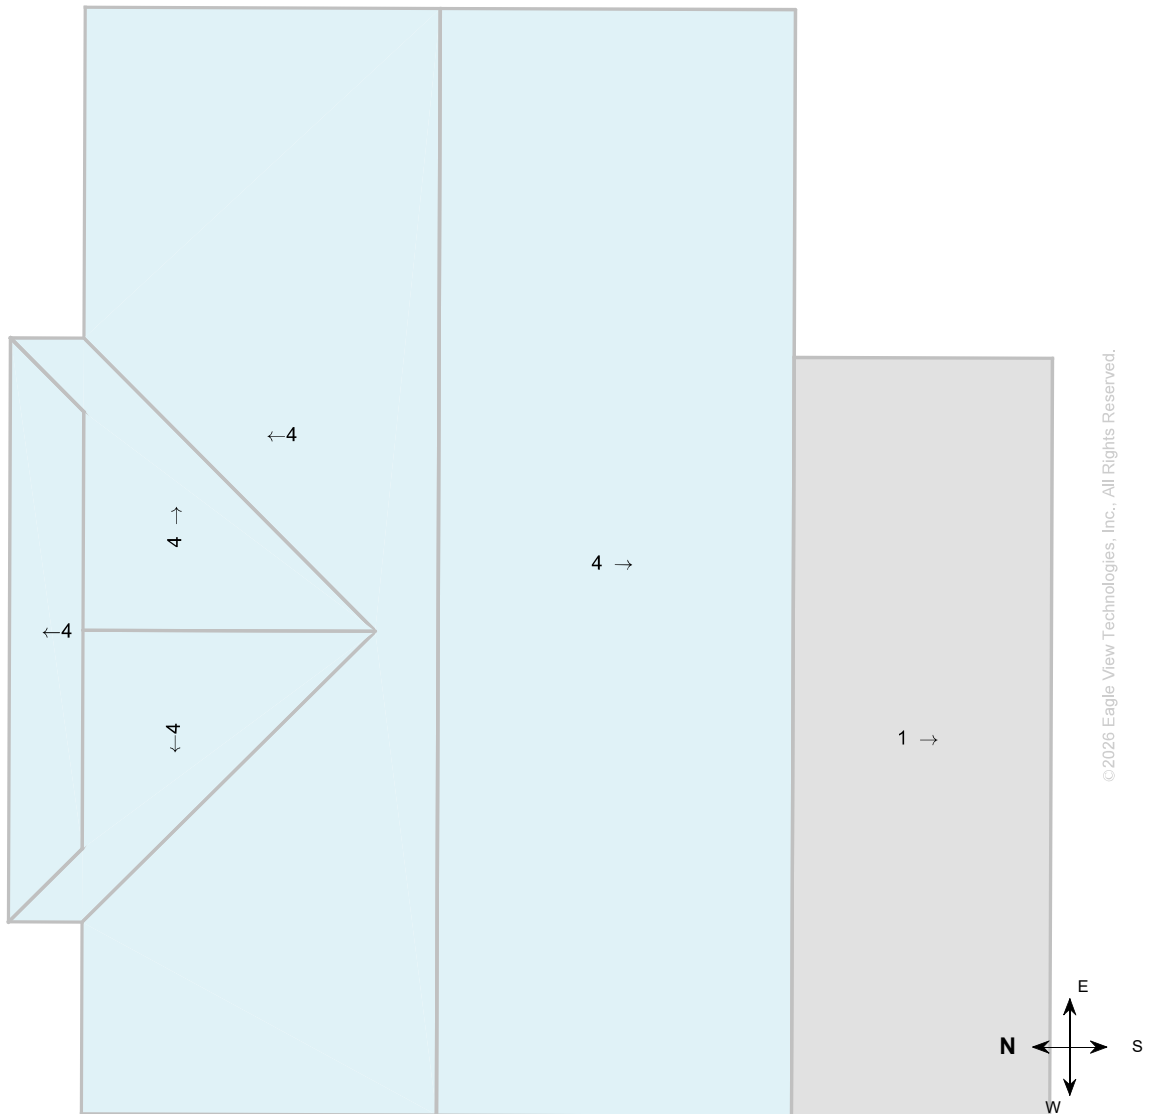
## PITCH DIAGRAM

Pitch values are shown in inches per foot, and arrows indicate slope direction. The predominant pitch on this roof is 4/12

Note: This diagram contains labeled pitches for facet areas larger than 20.0 square feet. In some cases, pitch labels have been removed for readability. Blue shading indicates a pitch of 3/12 and greater. Gray shading indicates flat, 1/12 or 2/12 pitches.

Roof Pitches	1/12	4/12
Area (sq ft)	403.4	1819.1
% of Roof	18.1%	81.8%

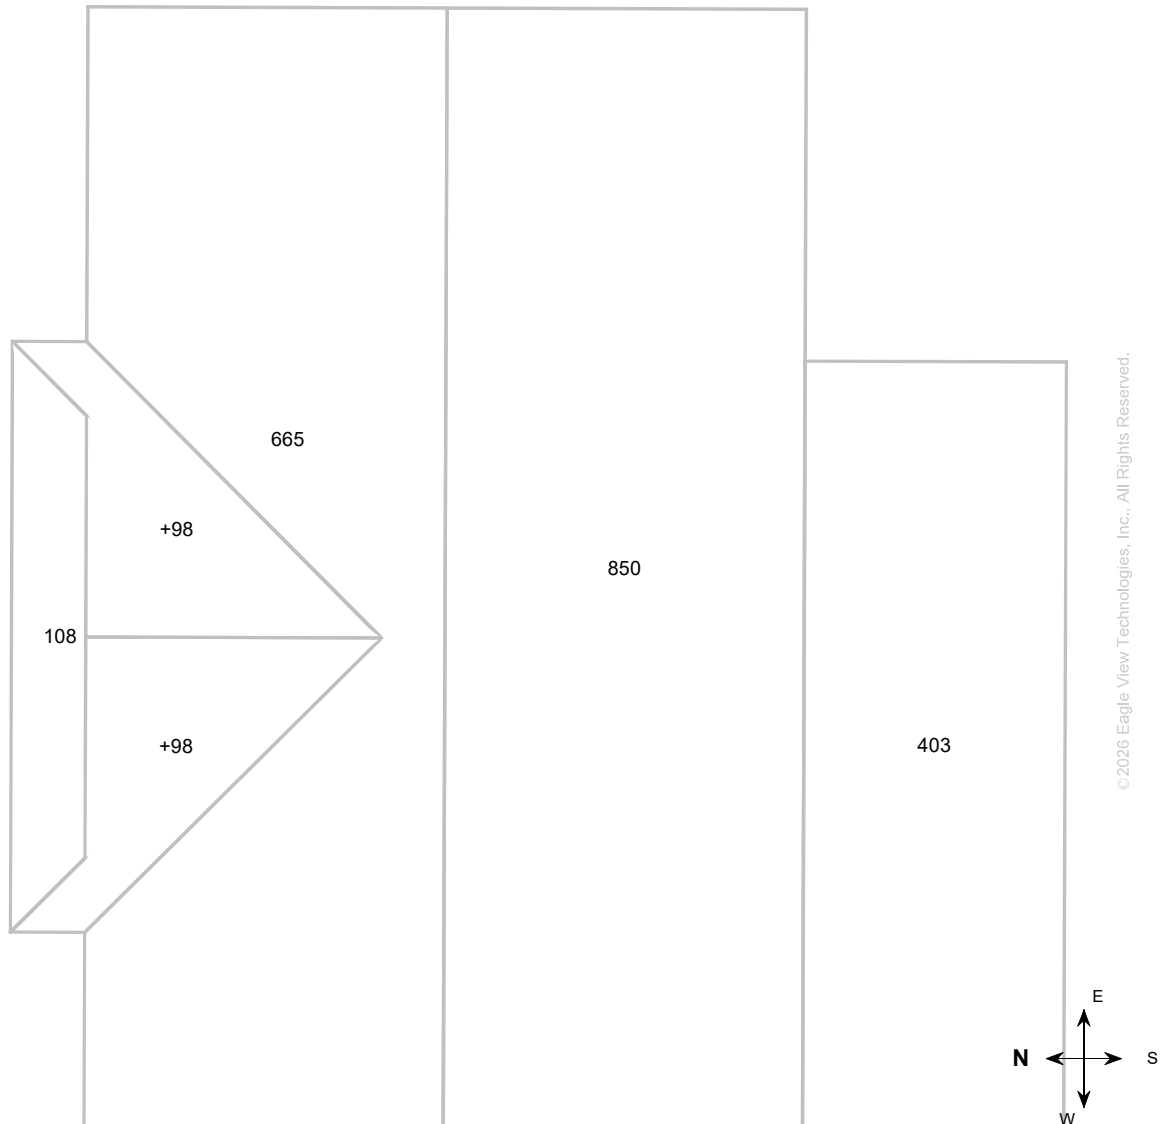
## AREA DIAGRAM

Total Area = 2,223 sq ft, with 6 facets.

Note: This diagram shows the square feet of each roof facet (rounded to the nearest Foot). The total area in square feet, at the top of this page, is based on the non-rounded values of each roof facet (rounded to the nearest square foot after being totaled).

**Total Area (All Pitches) = 2,223 sq ft**

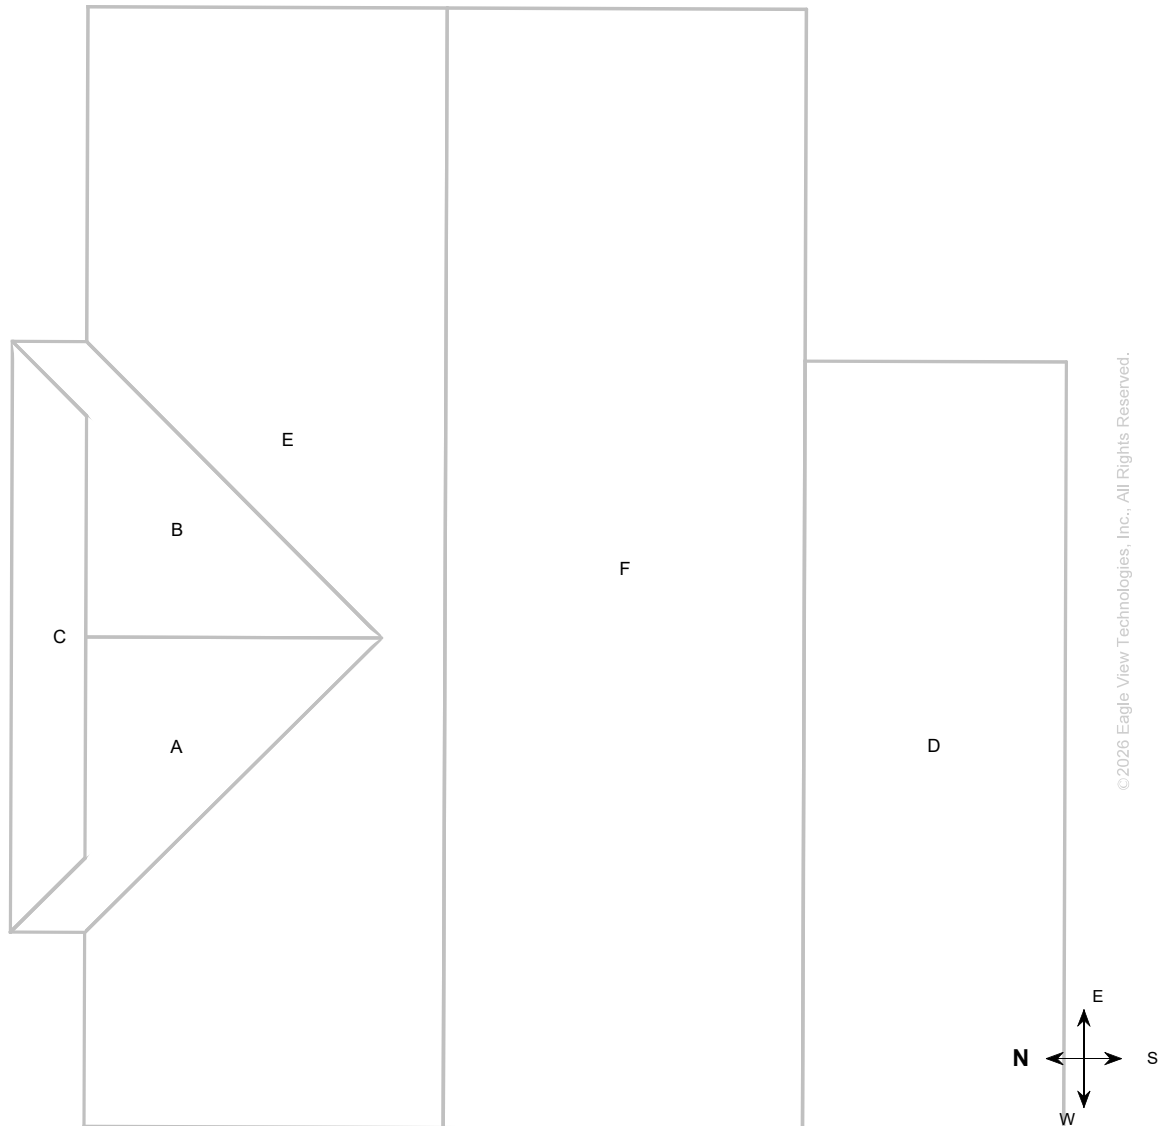
## NOTES DIAGRAM

Roof facets are labeled from smallest to largest (A to Z) for easy reference.
