CITY OF SUWANEE, GEORGIA
REQUEST FOR PROPOSALS

Suwanee Arts Center Design-Build Services

**Exhibit F - Structural
Assessment Report
prepared by Sterling M.
Cochran, S.E.**

STRUCTURAL Assessment Report

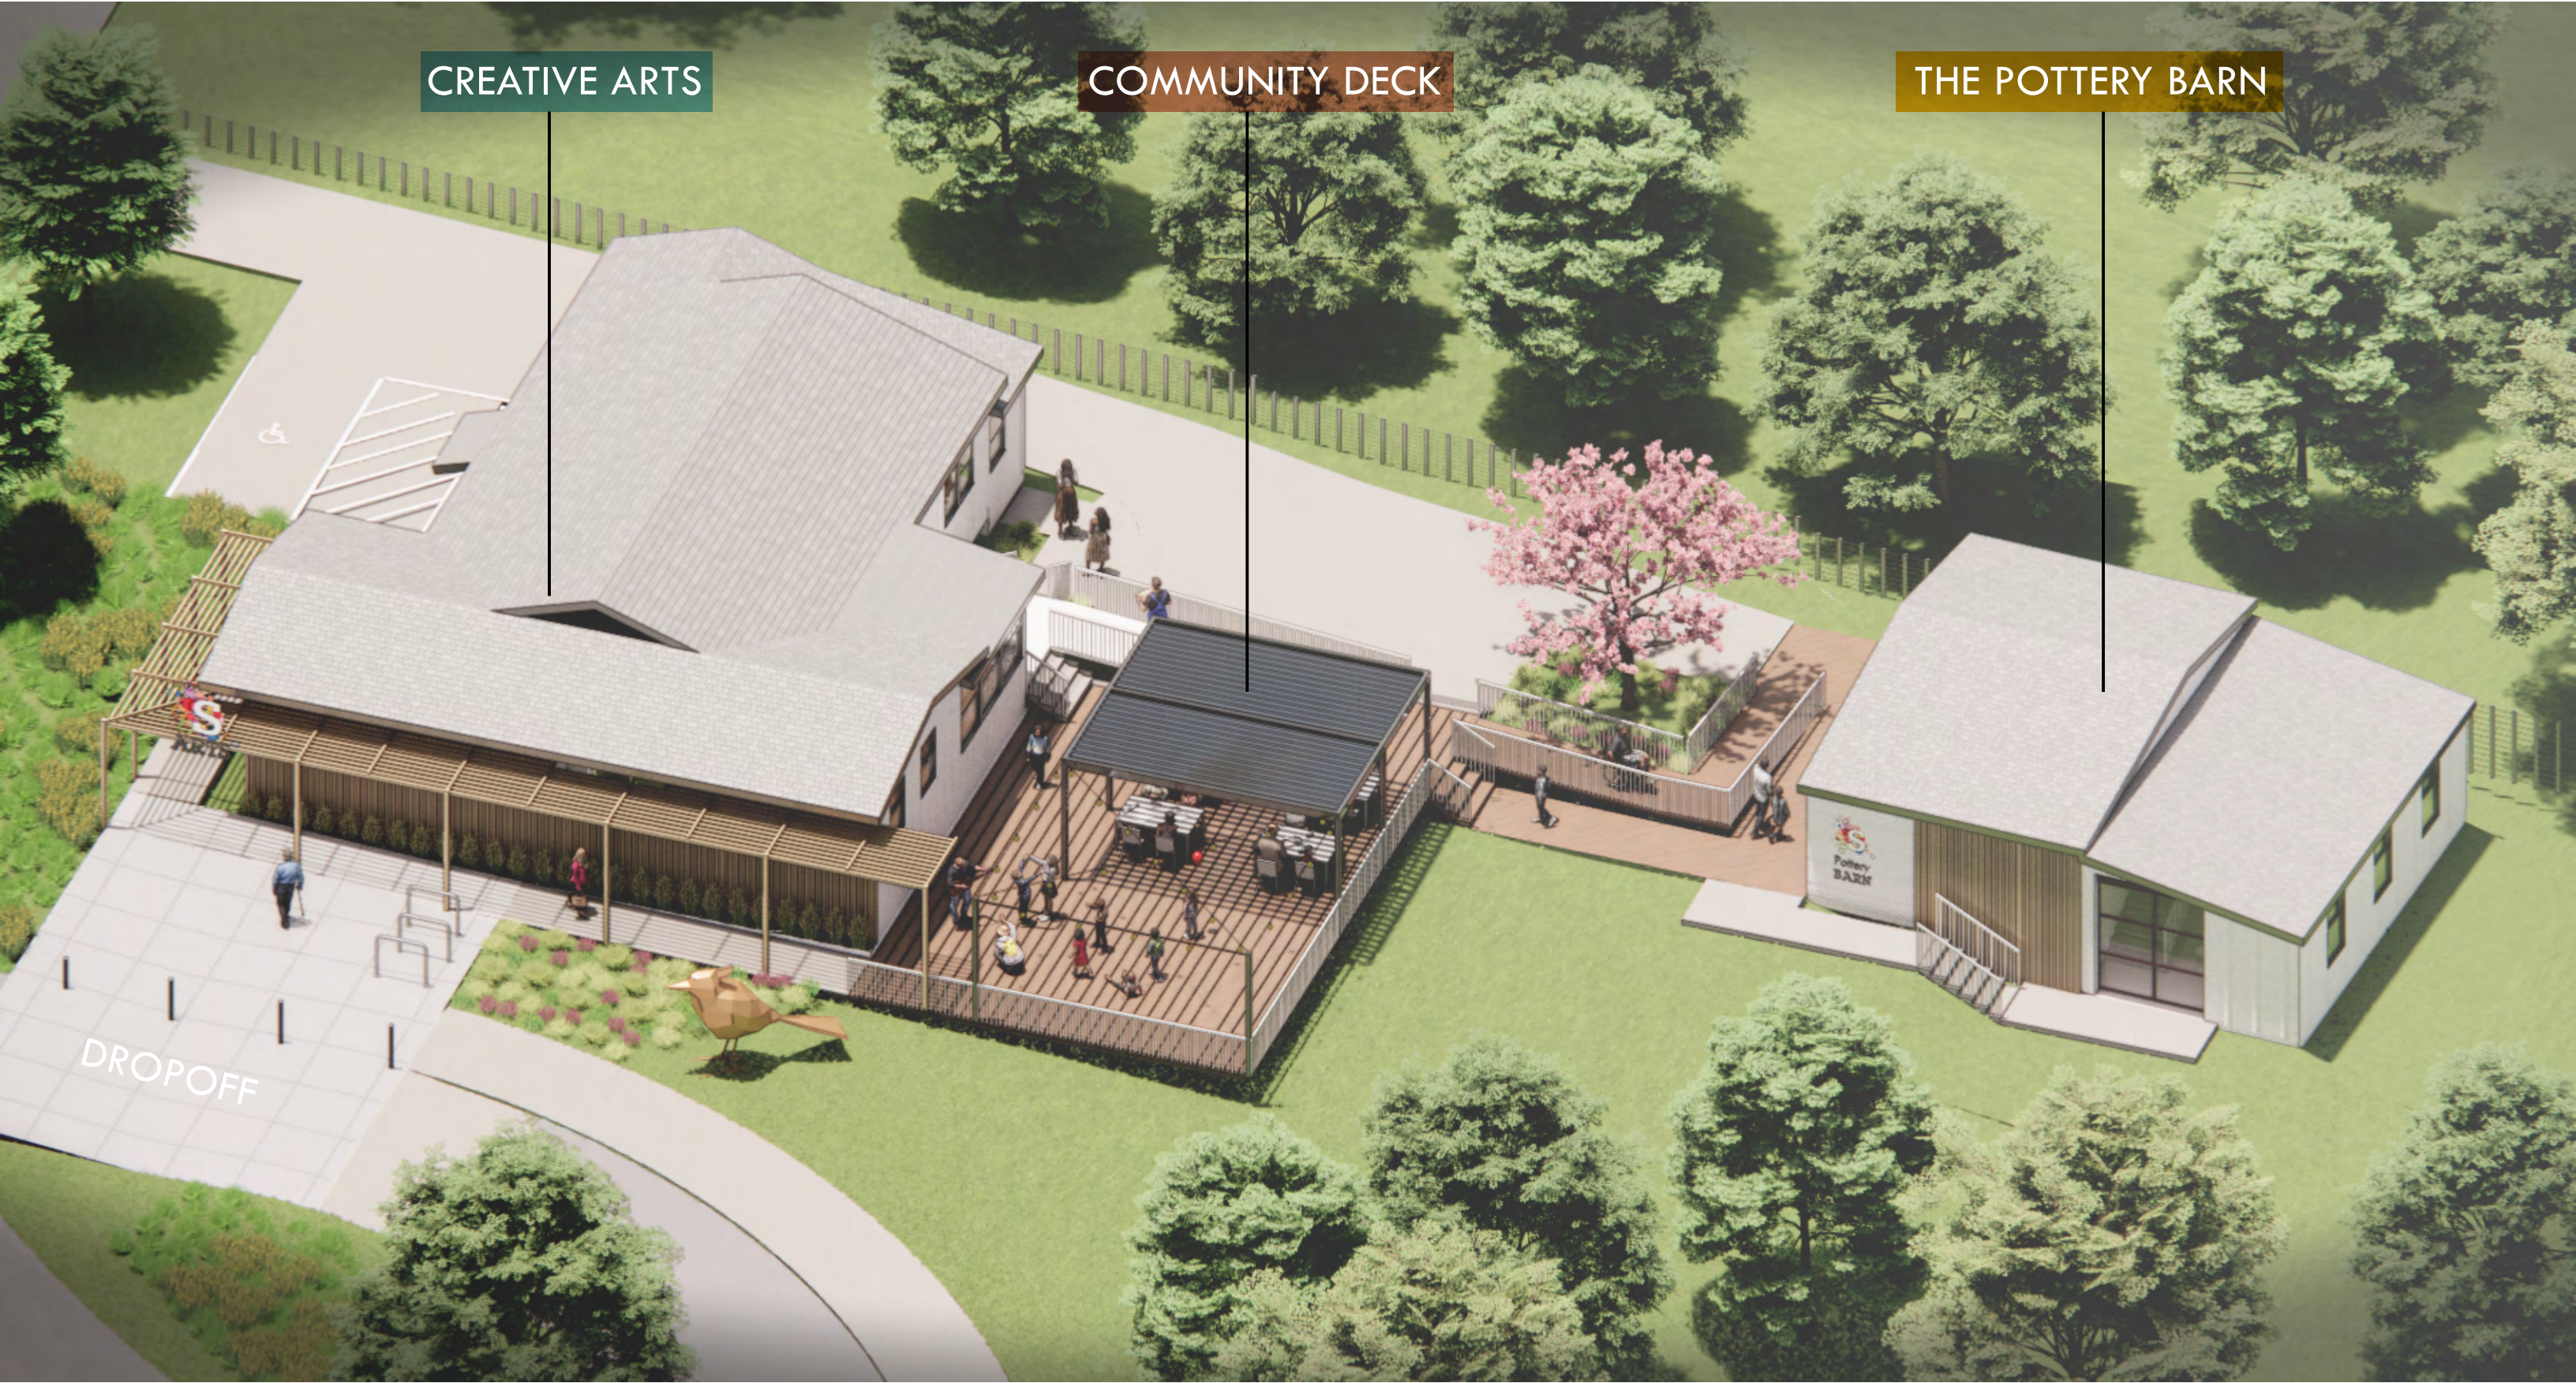
● ● ● suwane
ARTS CENTER VISION

CREATIVE ARTS, MEDIA, & GATHERING - Existing House

THE POTTERY BARN - Existing Shed

- 10 - Pottery Studio
- 11 - Pottery Classroom
- 12 - Kiln Room

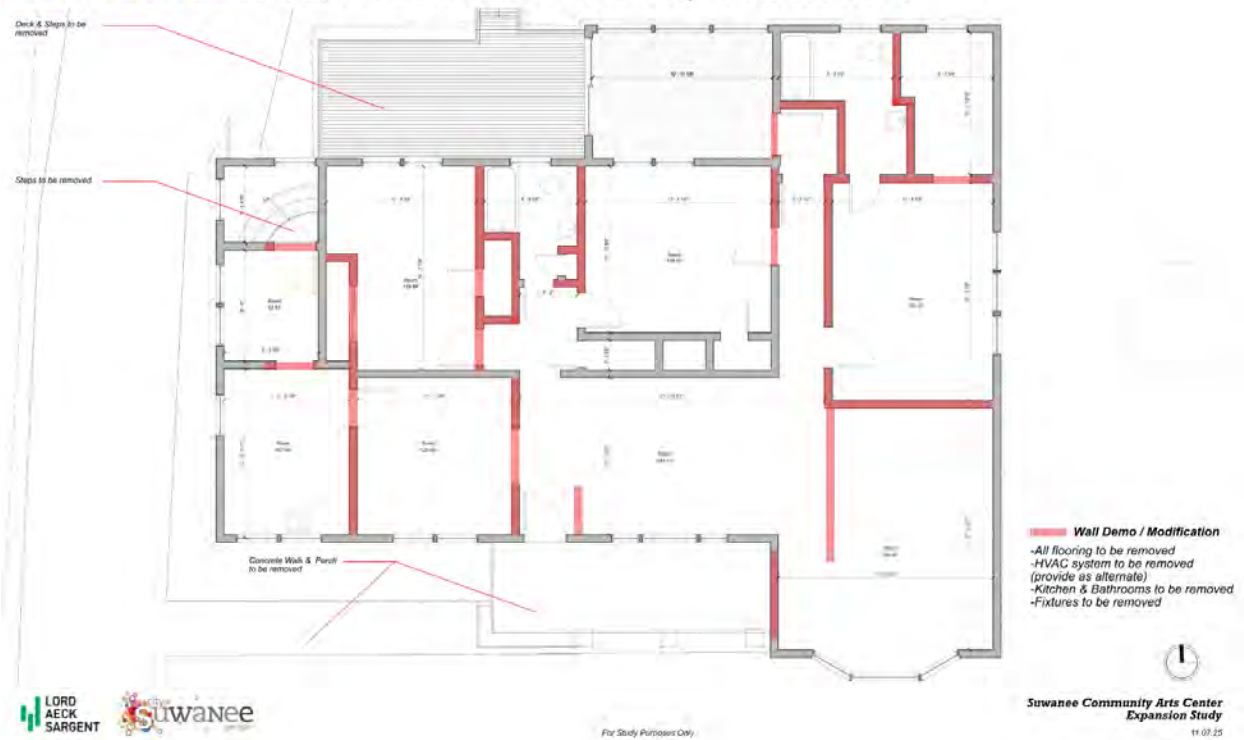
Figure 1: Wall Demo/Modification

Figure 1, from the document referenced above, shows the planned wall demo/modification plan.

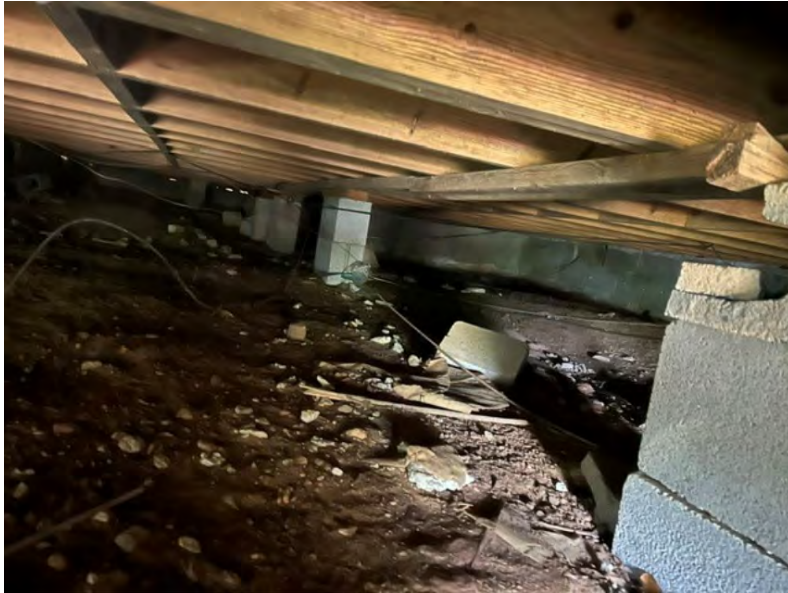
- P1** Floor framing at the east section of the house. This area appears to have been a later addition to the original construction. 2x8 (1-1/2" x 7" actual dimension) floor joists at 16" o.c. 15'-5"+/- long with an intermediate support creating a 2-span condition (7ft and 8ft spans). The support is a single 2x6 turned flatwise spanning 8ft to 9ft between CMU piers.

#	Location	Recommended Action
1	Floor framing – east section (Photos P1, P2)	Reuse of 2x8 joists is possible; replace flat-laid 2x6 support beam with 3-ply 2x12 spanning no more than 9 ft between rebuilt piers. Or install a continuous CMU stem wall under the 2x6 plate, instead of the 3-2x12, replacing the piers. A third option is a jack-post and beam system by a foundation solutions company
2	Support piers – all crawl-space areas	Rebuild CMU piers with proper grouting and mortar on new concrete footings; anchor wood beams to piers with Simpson Strong-Tie or equal connectors with vapor barrier protection.
3	Floor framing – X-marked area (Figure 2)	2x8 joists at 16" o.c. spanning a maximum of 8 ft are adequate; replace existing support members with 3-ply 2x12 at ≤ 9 ft pier spacing. Or install a continuous CMU stem wall under the 2x6 plate, instead of the 3-2x12, replacing the piers. A third option is a jack-post and beam system by a foundation solutions company

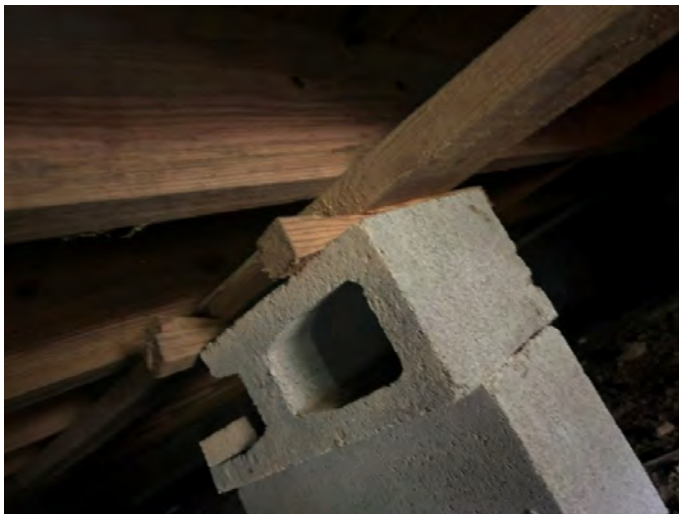
- P2** The CMU support pier construction varied by location. Courses appeared to be stacked using different methods. No mortar or grout was observed at the visible areas of the piers; however, not all piers were fully accessible or reviewed at the time of inspection.

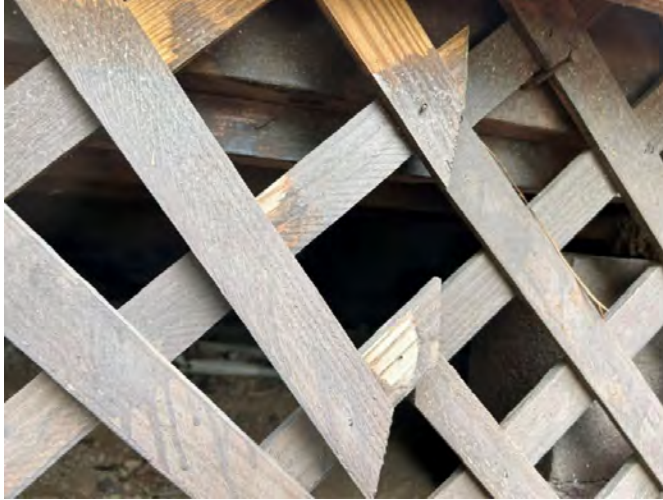
**P3**

The area marked with an "X" in Figure 2 was isolated from the remainder of the crawl space by CMU wall framing and was not directly accessible during the inspection. The photograph was taken from the exterior through the lattice enclosure. Construction in this area appeared similar to the east section shown in Photo P1; however, the support member consisted of a 2x6 installed with the strong axis oriented vertically, rather than laid flat-wise.

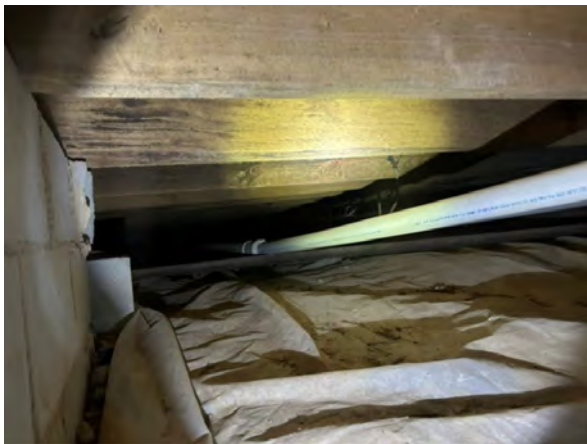
**P4**

At the front portion of the house, the floor joists were observed spanning approximately 12 feet in the north-south direction and were supported at each end by CMU stem walls. This framing consisted of rough-cut 2x8 lumber joists with actual dimensions of approximately 2 inches by 8 inches. The joists were spaced at 24" +/- o.c.

5. At the front portion of the house (Photos P4 and P5), rough-cut 2x8 joists at 24 inches on center span approximately 12 feet — too long to support the 50 psf design live load without strengthening. Repair specifications for each area, including replacement beam sizing, the CMU stem-wall alternative, joist sistering, pier reconstruction, and connection requirements, are provided in the Summary of Recommendations (Section IV).

4	Floor framing – front section (Photos P4, P5)	Strengthen rough-cut 2x8 joists by adding a full-depth sister member or providing a midspan beam; document fastener schedule per NDS; confirm deflection limit.
5	Roof framing	Confirm load path of strong-back bracing to bearing walls; modify ceiling joists if any bearing walls are to be removed. Evaluate rafter anchorage as part of a final structural design package
6	Foundation – perimeter stem walls / interior pier footings	Evaluate perimeter CMU stem walls and footings under interior piers as part of the final structural design package.
7	Lateral system	Assess and upgrade shear walls, anchorage, and diaphragm-to-wall connections due to alteration classification in accordance with the IEBC; coordinate with the AHJ.
8	Shed building	Restrict access pending re-evaluation; if future occupancy is planned, rebuild upper floor framing and roof and re-evaluate foundations.

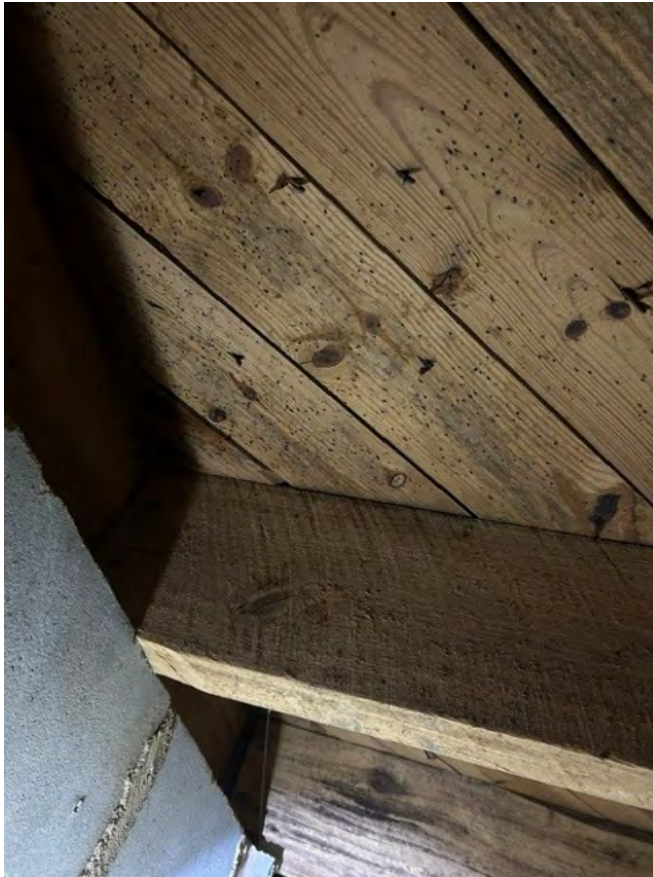
**P5**

Photo P5 is the same location as P4. It appeared that there were no connectors tying the joists to the CMU. Refer to the associated action item summarized in Section 4.0 (IV). The same condition exists at the front of the house, at the opposite end of the 2x8.

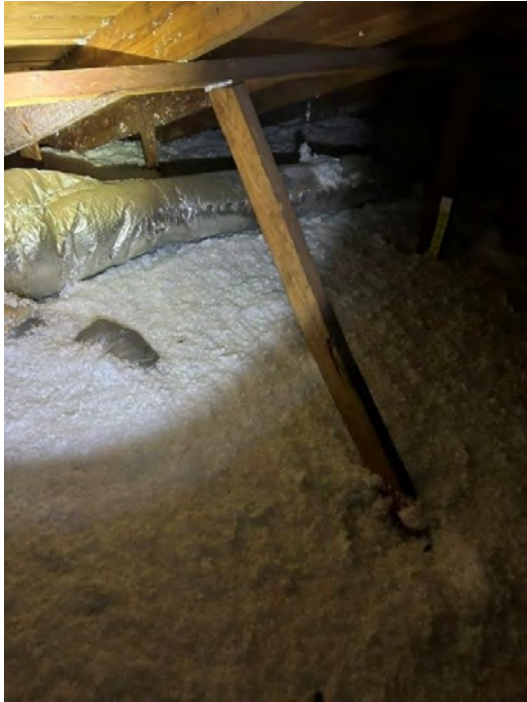
- P6** The roof framing consisted of 2x10 rafters spaced at approximately 24 inches on center, spanning from the front and rear walls to the ridge located near the center of the house. Strong-back bracing with kicker braces was installed approximately 9 feet and 11 feet from the supporting walls.

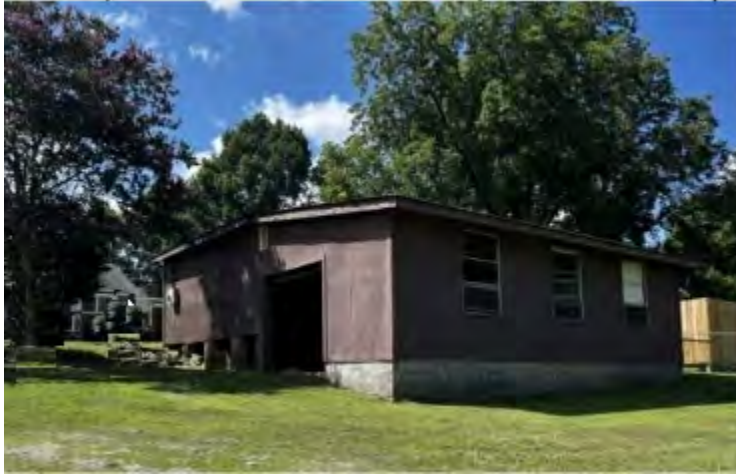
- P7** The upper middle room of the shed had noticeable deflection in the floor while walking over it. Part of the roof over the upper rooms appeared to be sagging. If the shed is to be used in the future, it will likely need to have the upper floor and the roof above rebuilt.

The upper middle room of the shed exhibited noticeable floor deflection during the site visit, and portions of the roof above the upper rooms appeared to be sagging. Access to the shed should be restricted pending re-evaluation. Should future occupancy be planned, the upper-level floor framing and roof will likely require rebuilding, and a separate evaluation of the shed foundations will also be required. The associated action item is summarized in Section IV.
