City of Palo Alto Water System Pipe Replacement

*Prepared for:
City of Palo Alto*

*G&E Engineering Systems Inc.
6315 Swainland Rd
Oakland, CA 94611
(510) 595-9453 eidinger@geEngineeringSystems.com*

*G&E Report 119.01.02, Revision 0
July 21, 2015*

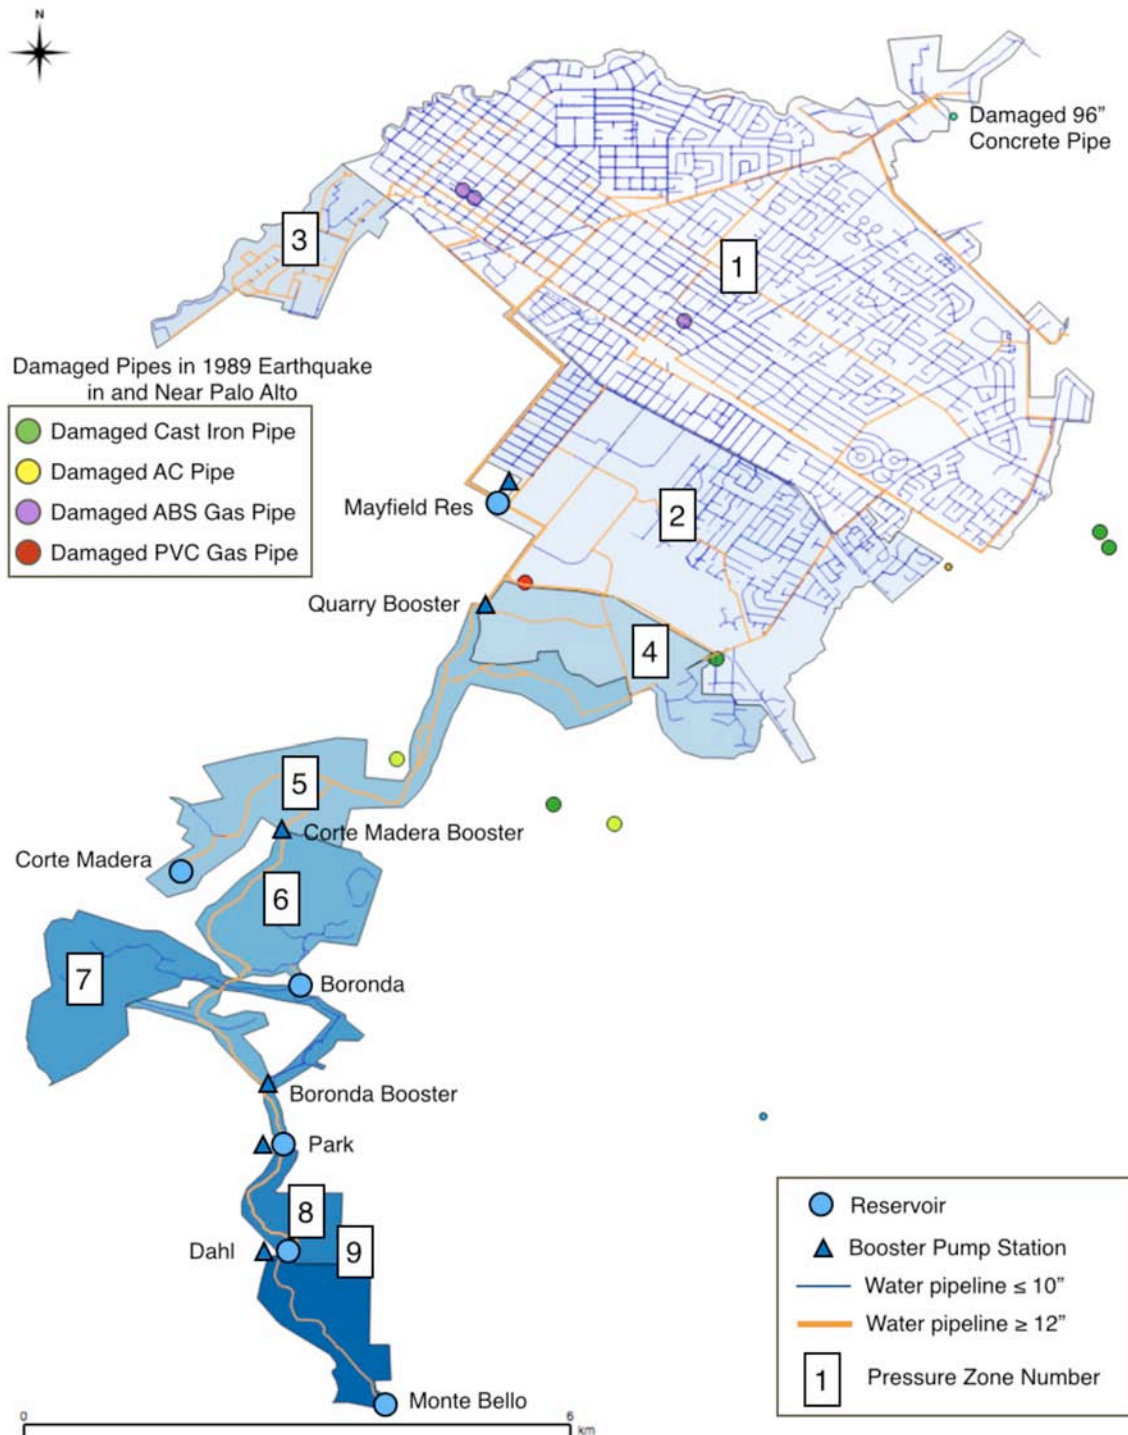
Figure 3-38. Repairs to Buried Pipe Near Palo Alto, 1989 Loma Prieta Earthquake

The following explains the various leak repairs (small or large dots) in Figure 3-38:

- The blue lines represent the modern Palo Alto water system pipes. Palo Alto reported no damage to any water pipe in the 1989 earthquake.

- The small dot in central Palo Alto is bad data.

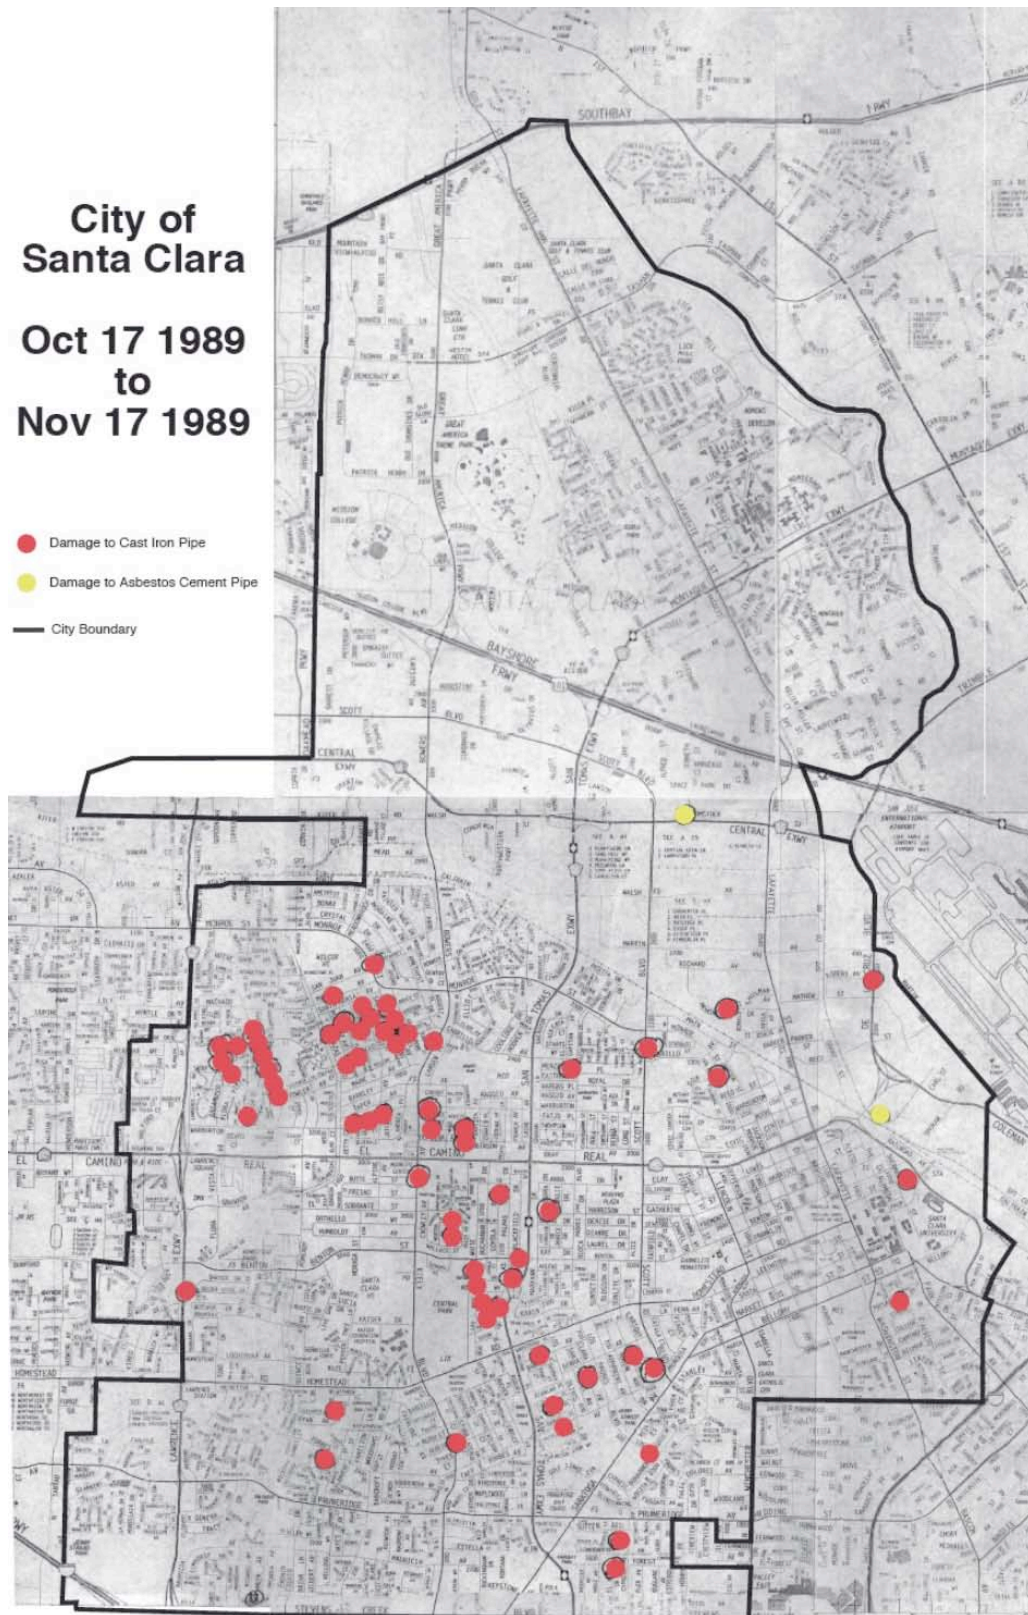
Figure 3-40. Repairs to Buried Water Pipe, City of Santa Clara

Figure 3-40 shows the locations of damaged water pipes (66 total) in the City of Santa Clara due to the 1989 earthquake (these dots are not included in Figure 3-39). 64 of the 66 repairs were to cast iron pipe. 1 (possibly 2) of the repairs were to AC pipe. There was no observed liquefaction at these pipe repair locations in the City of Santa Clara in the 1989 earthquake.

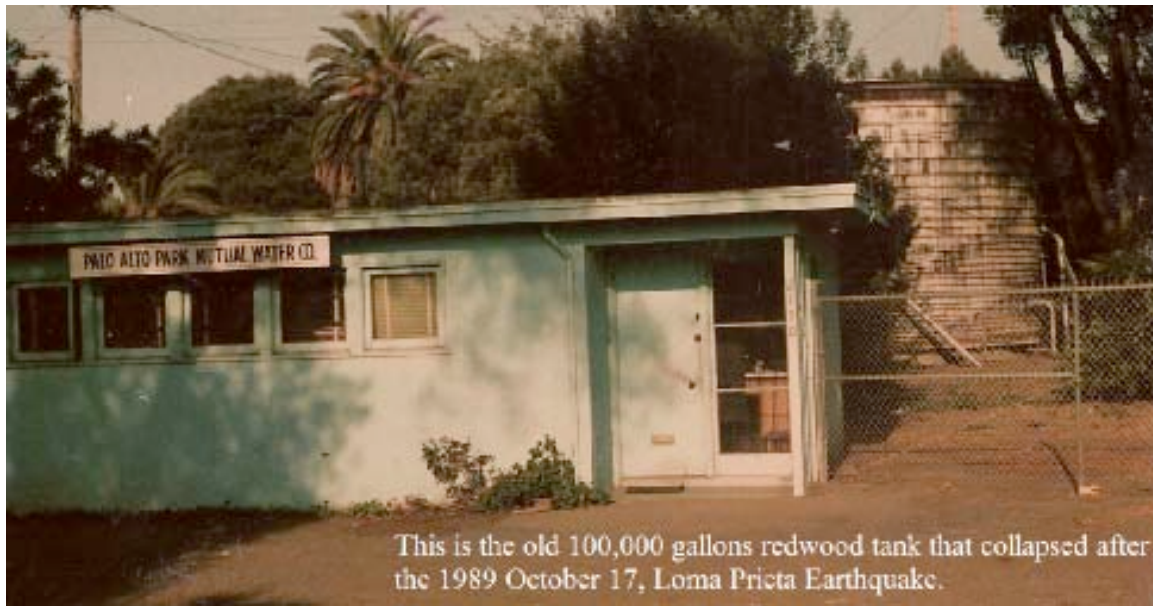
Figure 3-42. Palo Alto Park Mutual Water Company (pre-1989).

After the 1989 earthquake, the water system was "in a shambles", experiencing 2 or 3 leaks a day. The daily routine after the earthquake was to drive around spotting leaks, and then determine which could be repaired with in-house staff or with contractors. Well numbers 5 and 6 and the booster pump were damaged. The 100,000 gallon redwood tank (Figure 3-42) leaked and an attempt to repair the tank was unsuccessful, as when the tank was filled on December 20 1989, it collapsed. Without the tank, water from the wells was

being pumped into a closed system, and careful watch was needed to not over pressurize the pipes.

After the earthquake, a 7th well was drilled to 500 feet, wells 1 and 4 were abandoned, two tanks were added (11,500 gallons and 350,000 gallons) and the water system improved to use 8-inch and 6-inch mains throughout. The 350,000 gallon tank is an at-grade steel tank. FEMA paid for a portion of these improvements.

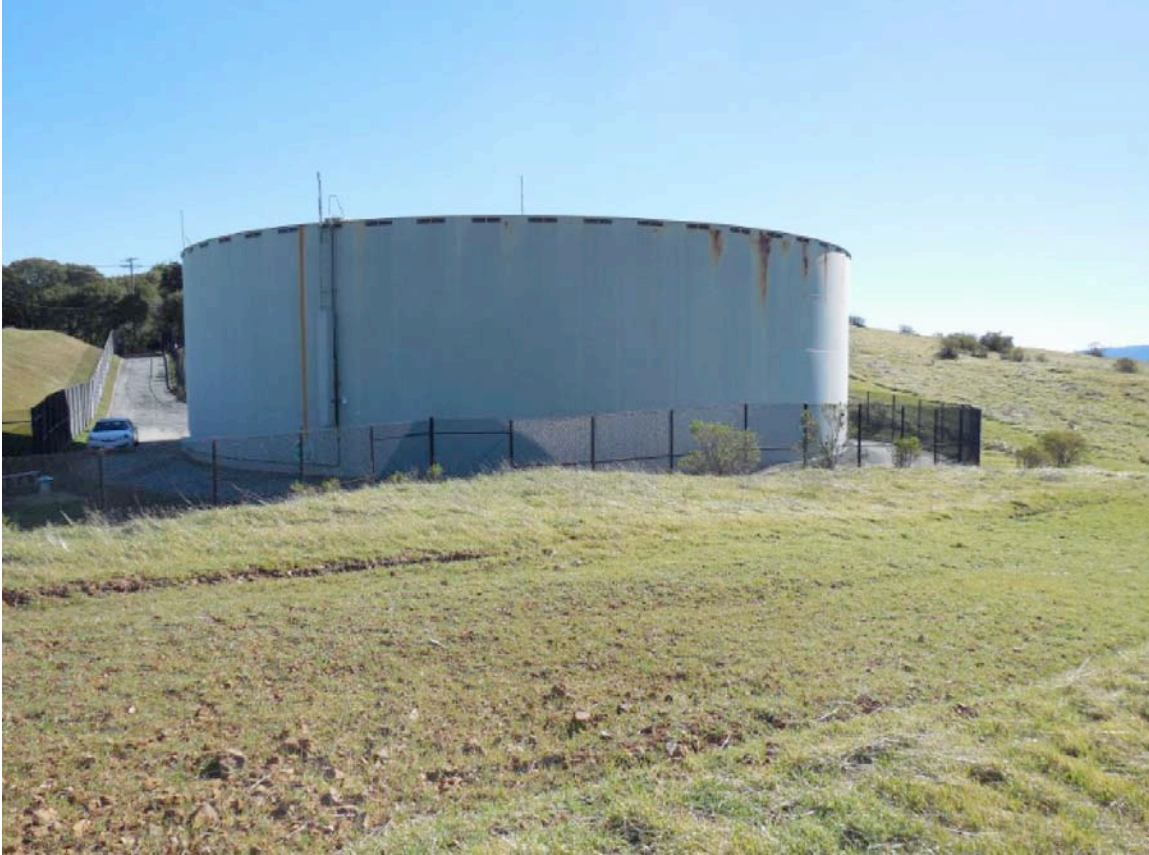
Figure 5-2. Monte Bello Reservoir. View Looking East

The plan and elevation for the Monte Bello Reservoir is provided on Sheet 22 (CPA 1964). Figures 5-2 to 5-5 provide an overview of the site conditions and features of geologic interest. The reservoir appears to be located on a cut pad. The depth to weathered rock is estimated to be shallow on the basis of the exposed cut along the E-SE side of the site and the rock (limestone) outcrops observed in proximity to the reservoir. The surficial geology in the area has been mapped (Dibble 1966, Brabb 1993) as consisting of various sub-units of the Franciscan formation (sandstone, greywacke, limestone, and chert).

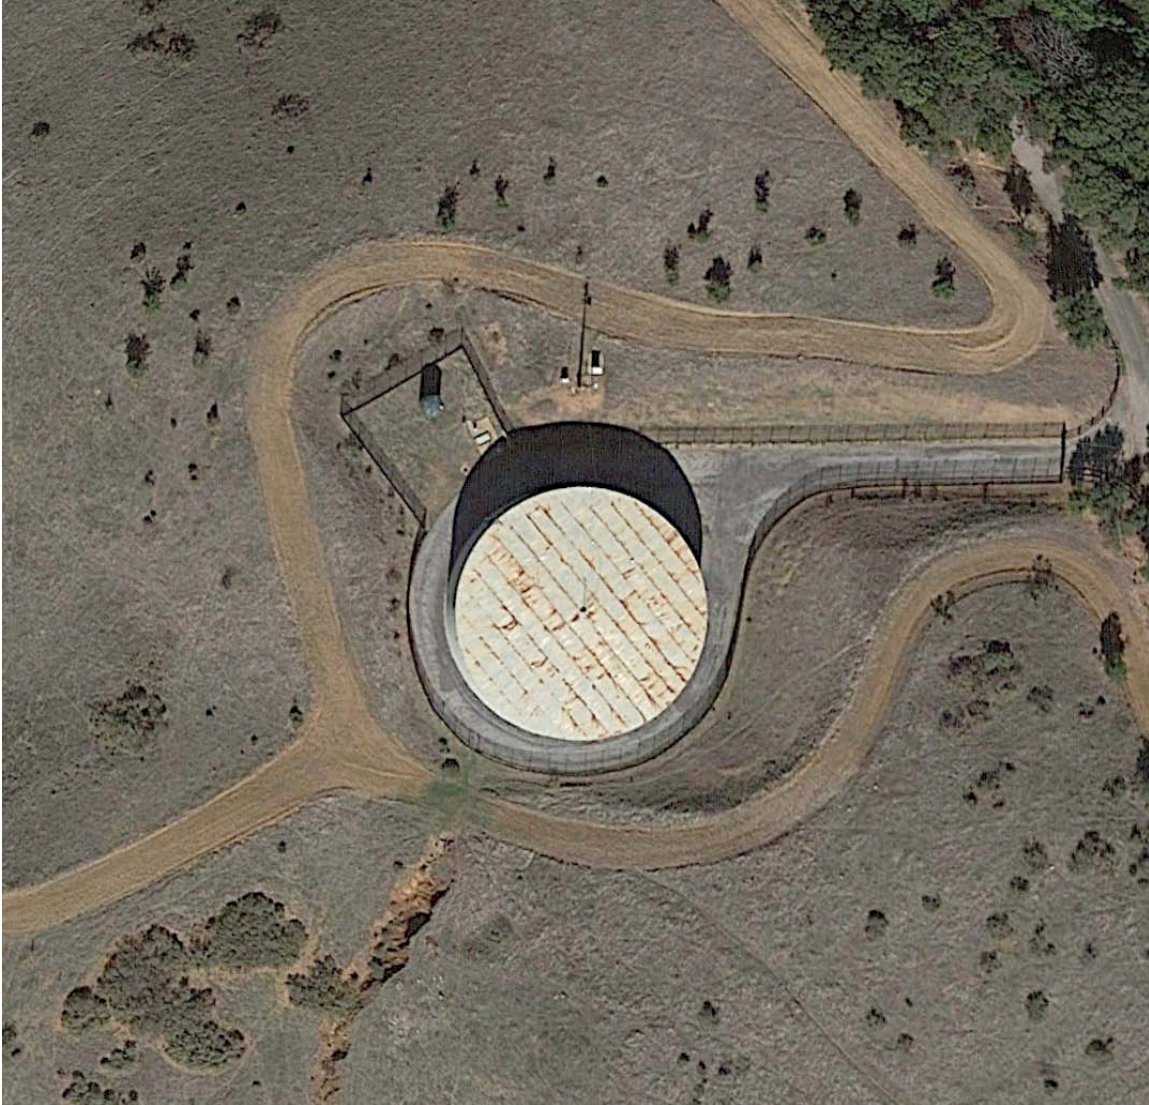
Figure 5-3. Monte Bello Reservoir. Aerial Image (North Up)

A pronounced gully is located along the southwest portion of the reservoir; thus gully is seen in Figure 5-3 in the lower left quadrant. The gully has formed beneath a surface storm drain outlet for the tank site. The erosion and gullying provided an exposure of the soils and highly weathered bedrock adjacent to the tank site (Figures 5-4 and 5-5). The gully has incised roughly 12 feet into the soil and weathered rock. The exposed soil appears to be colluvium and residual material weathered in-place from parent rock. The composition is predominantly fine-grained with gravel-sized inclusions of limestone, siltstone, and sandstone. Relic bedrock structure was evident in portions of the gully. The gully side slopes are approximately 40° to 50°.

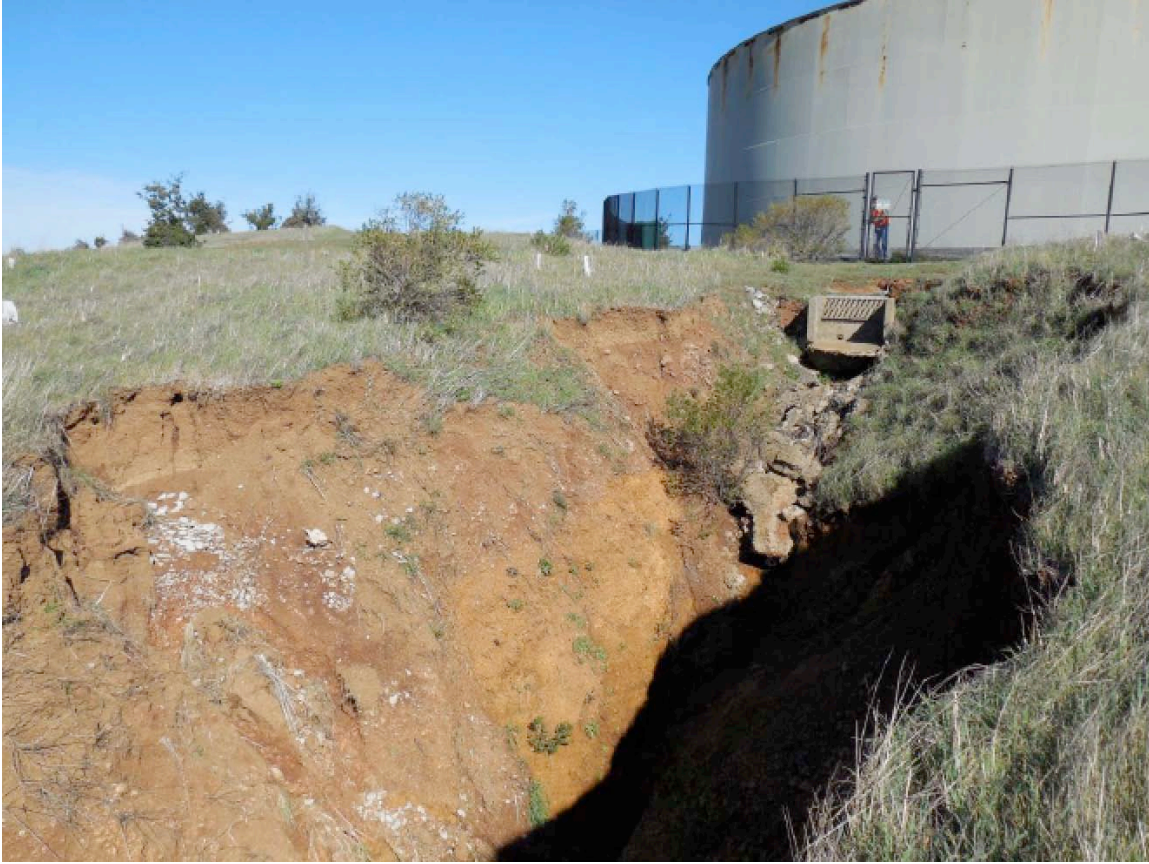
Figure 5-4. Active erosion and gully formed by storm drain, southeast side of reservoir

This may have led to the characterization of this feature as a landslide in regional geo-hazard map (grey polygon to the west of the tank in Figure 3-34), but our field observations did not confirm evidence of active sliding to the west of the tank. It is our understanding that a primary cause of the increased rate of erosion that formed this gully is the surface run-off from the storm drain outlet, that appears to have dramatically increased the gullying since 1953 prior to construction of the reservoir (i.e., the earliest Google Earth image for the site).

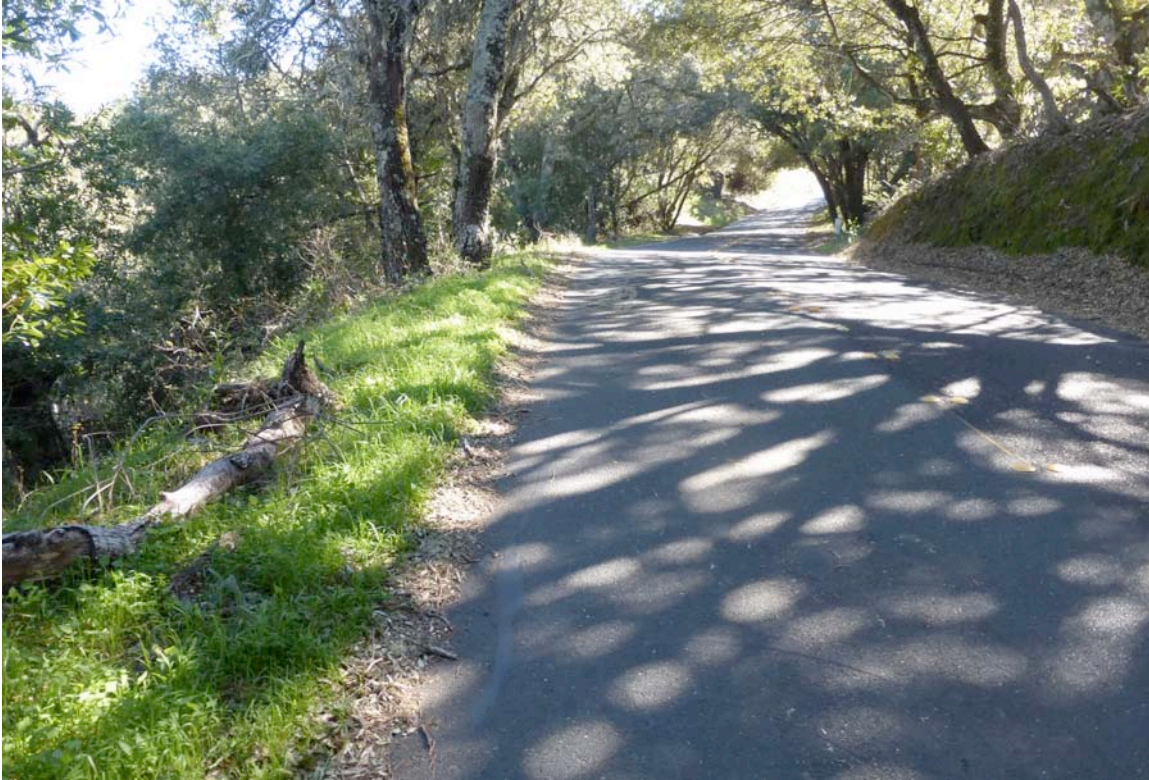
Figure 5-6. Page Mill Road Between Monte Bello and Dahl Reservoirs

The pipeline follows Page Mill Road northerly to the Dahl Reservoir and Booster Station. This portion of the alignment was walked. Figure 5-6 shows the roadway, in which the CCP is located, along with a typical side slope. General observations are summarized as follows:

- The roadway appears to be in very good shape. No evidence of large-scale or deep-seated soil movement was evident. With the exception of general aging and localized alligator cracking, the pavement appeared overall to be in good condition and did not provide evidence for substantial soil movement.
- Shallow road cuts (generally less than 10 to 15 feet tall) were in good condition.
- Road fill along steeper slopes appears to be very isolated.
- Portions of Page Mill Road follow a broad ridgeline with steeper slopes (approximately 1V:3H to 1V:4H) on one or both sides of the roadway. Very little evidence of soil movement was observed along the roadway in these areas.

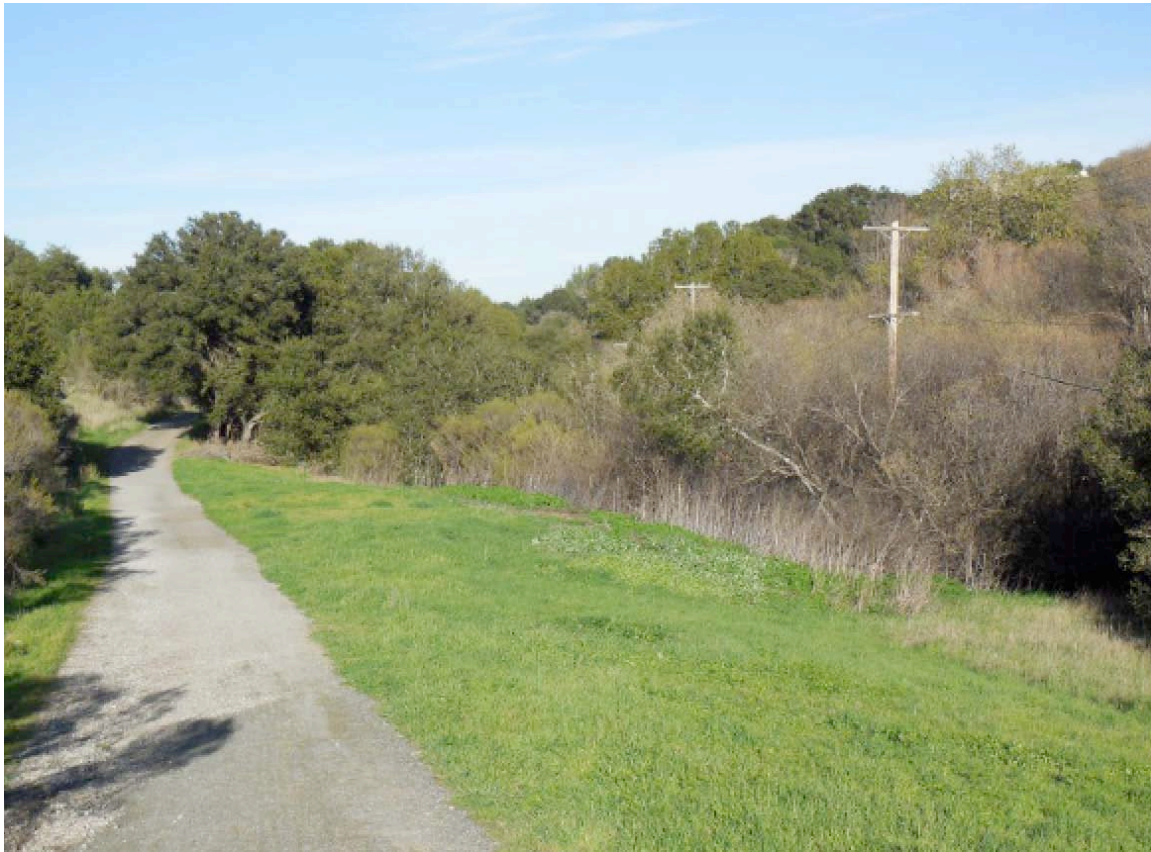
Figure 5-7. General geomorphology along Arastradero Creek. View looking northerly. Creek is to right side of the photo. Pipeline generally follows roadway.

The lower half of this portion of the pipeline alignment is mapped as a zone of Very High liquefaction hazard (Figure 3-22) due to young alluvial soil and high groundwater table adjacent the Arastradero Creek. The morphology of the valley bottom and creek channel along parts of this alignment can be characterized as a broad and shallow (Figure 5-7). The low gradient and apparently low flows along the portion of the creek observed has resulted in the deposition of predominantly fine-grained soils. A soil boring located above the Very High hazard zone (Station 174+75) revealed the following (ABM #583_Foothills 62-8.pdf 1964):

The broad nature of the valley floor, very shallow creek channel, and predominantly fine-grained nature of the soils observed collectively reduce the liquefaction hazard along this portion of the pipeline alignment. Along a portion of the alignment, the pipeline is embedded at an elevation that is lower than the base of the stream channel further reducing the likelihood of lateral spreading-induced damage to the pipeline.

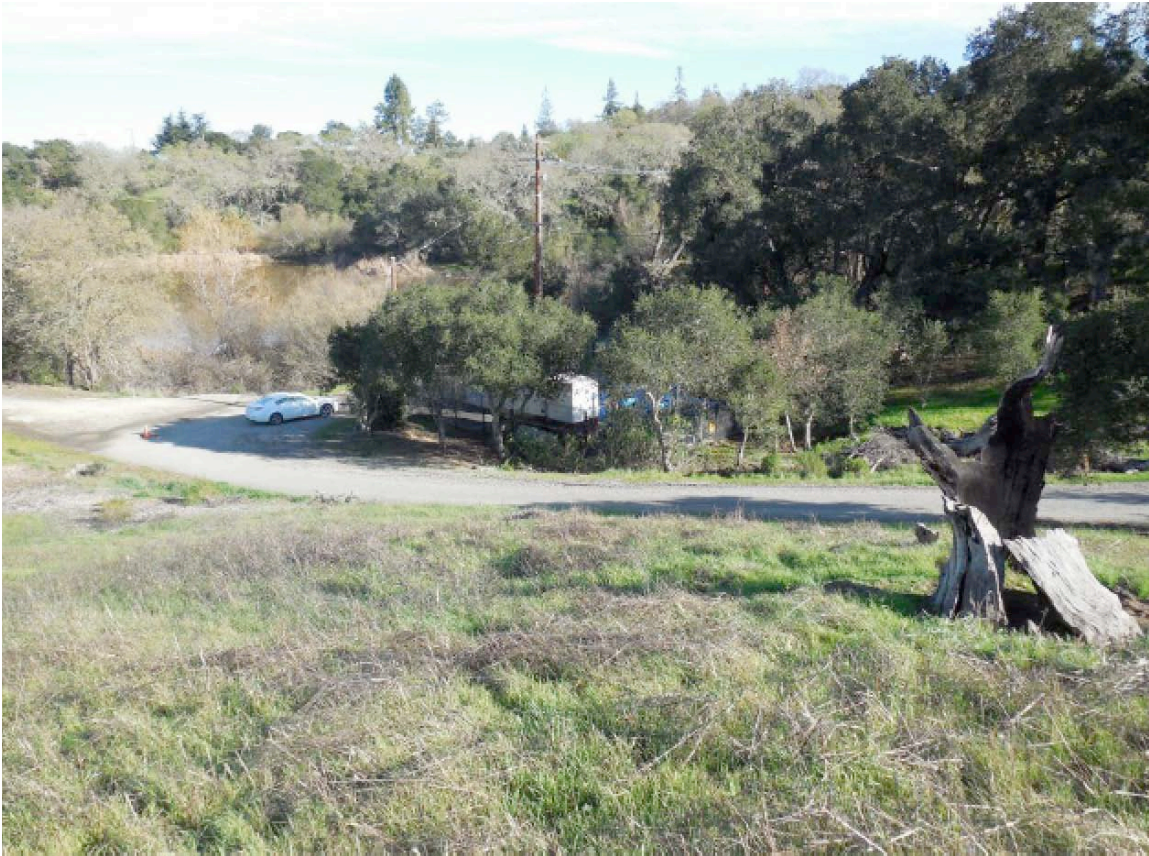
Observations made around the booster site did not reveal evidence for pronounced soil creep, slope instability, or settlement of foundations or slab-on-grade. Overall, the booster site appears to be in very good condition.

The potential for seismically-induced settlement of the booster station fill and underlying alluvial soils should be evaluated in light of the high groundwater levels observed. A modest amount of differential movements of the booster pump station site could cause leaks or a full break of the below-grade pipes entering / leaving the pump station (more likely). Inertial shaking is not likely to cause breaks to any of the above ground pipes within the booster pump station site, but minor leaks at couplings or air release valves could still occur.

Figure 5-8. Corte Madera Booster Pump station Site. View is looking easterly, downslope. Arastradero Lake is beyond the car in the background.

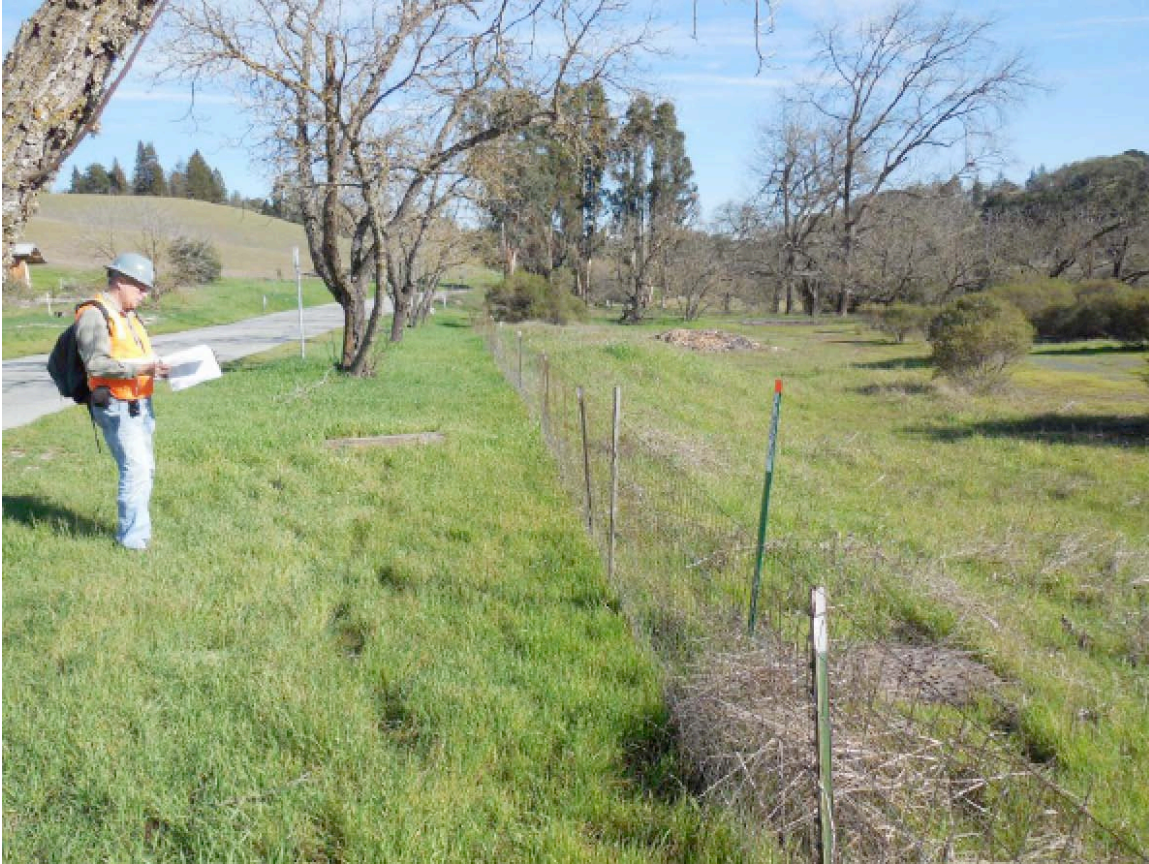
The portion of the pipeline alignment that was observed extends between Station 105+00 and 112+00 (1960). This portion of the alignment is located across Arastradero Road from the Enid W. Pearson Arastradero Preserve parking area (Palo Alto Open Space) and it is distinguished in the plan sheets as the location of an approximately 90 degree bend in the pipeline alignment. This section of the Foothills pipeline network is characterized as a zone of High liquefaction hazard (Figure 3-19). Figure 5-9 shows a portion of the alignment parallel to the roadway.

Figure 5-9. Pipeline alignment along Arastradero. Road is to left. Creek is in the lowlands to the right. Pipe runs parallel and between the road and creek. Eidinger stands near a vault hatch believed to be above the pipe.

Given these issues, the pipe in the High and Very High liquefaction zones in Figure 3-19 are possibly subject to local settlements of an inch or so, and we think a very modest chance of being subject to a lateral spread towards the creek. However, given the lack of detailed subsurface information, the implications of a relatively low liquefaction risk at a few locations cannot be generalized with confidence to the entire alignment. Had this pipeline been design today, this section of the alignment (Figures 3-16 and 3-19) would probably have been specified to have fully restrained joints capable of reliably sustaining at least a couple of inches of differential settlement.

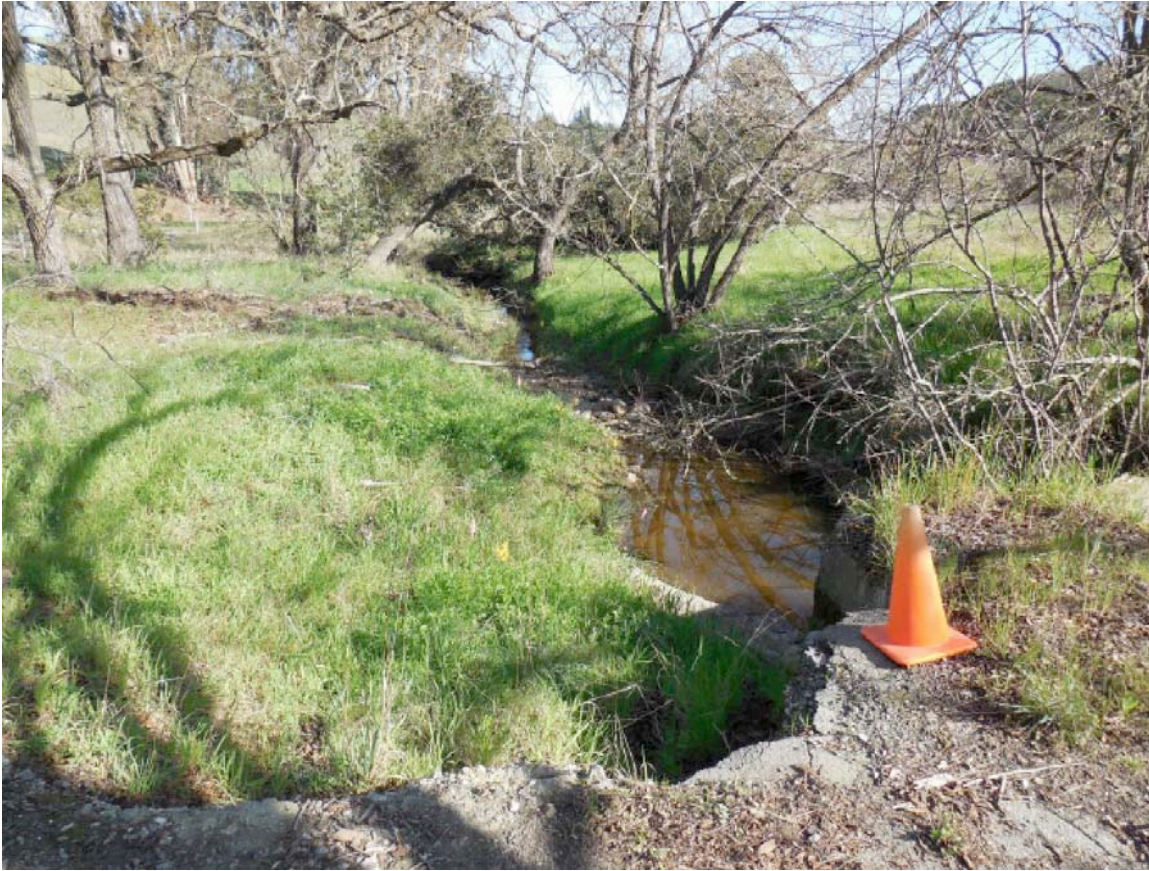
In this area Arastradero Creek flows through a broad, flat valley floor. The creek is very low gradient and exhibits a shallow channel (generally less than 2 to 4 ft in the area observed). Figure 5-10 highlights a portion of the creek located approximately 250 feet to the east (downstream) of the entrance to the Pearson Arastradero Preserve. At this location the slope from Arastradero Road (i.e., the pipeline location) to the creek channel is low (approximately 1V:15H to 1V:18H). The gradient from the base of the buried pipe is much lower, indicating that at this location the potential for damaging lateral spreading due to liquefaction is minor. The soils exposed in and along the stream channel were predominantly fine-grained, or contained sandy material in a matrix of fine-grained soil. This exposed soil is judged to have a low potential for liquefaction. Taken collectively, the exposed soil type, shallow slope, distance from the pipeline alignment to the stream channel, and the depth of embedment of the CCP suggests that the liquefaction hazard at this site is very minor despite the characterization as "High" hazard on regional maps (Figure 3-19). The potential exists for lenses and layers of loose sandy soils that are vulnerable to liquefaction; however, the potential impact of these layers (of unknown vertical and lateral extent) must be evaluated in light of the slope angles and distance from the pipeline alignment to the stream channel.

Figure 5-10. Arastradero Creek.

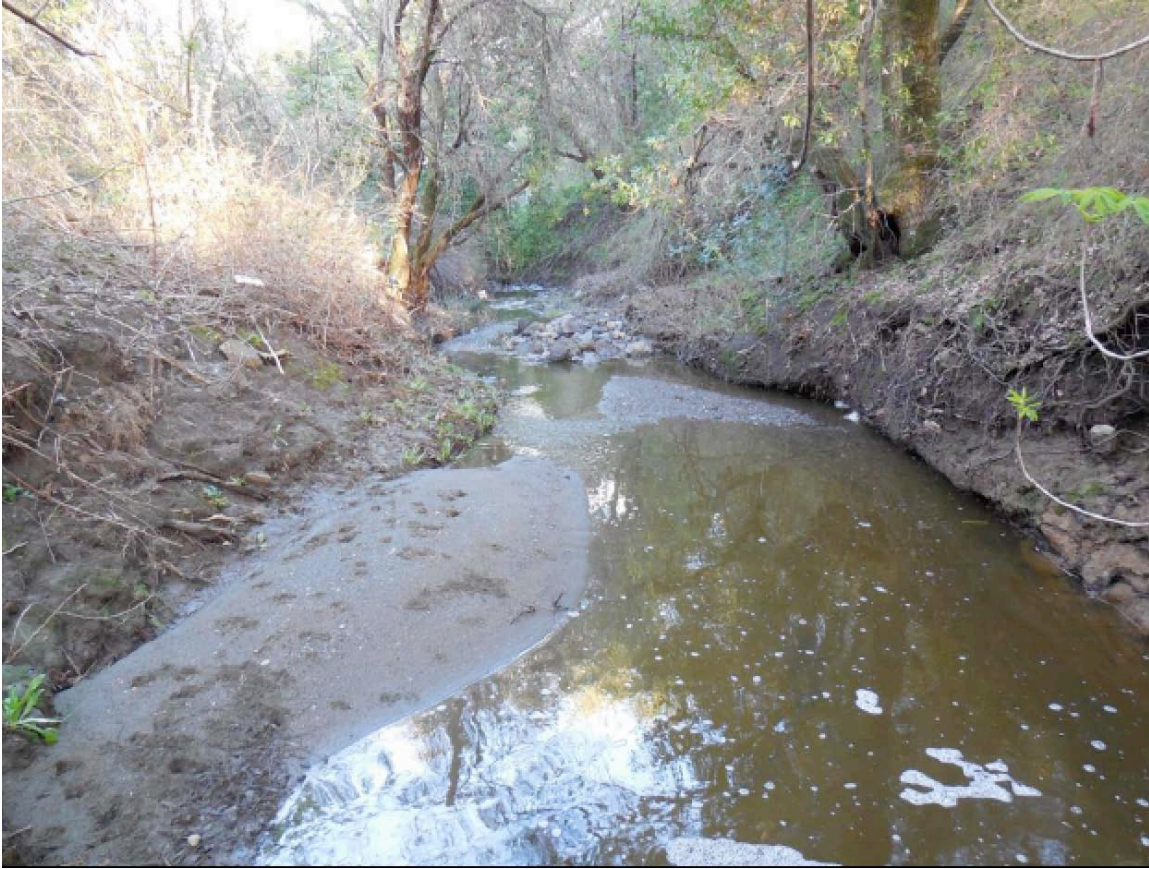
- The bed load (channel fill) is predominantly loose, granular soil. This soil is highly vulnerable to liquefaction during seismic loading.
- The soil exposed in the banks of the stream is predominantly fine-grained and it appears to be either a weathering product of the parent rock (Page Mill basalt of Dibblee 1966) or older alluvium. In either case the stiff fine-grained soil along the banks and stream terrace is not considered vulnerable to liquefaction, although strong ground shaking could result in permanent deformation along over-steepened portions of the channel and areas adjacent to sloping road fill.

- The thickness of the potentially liquefiable soils appears to be small at this location based on the surface exposures and stream bank morphology.
- The concrete encasement for the CCP is exposed in the stream channel (Figure 5-11). If this location was constructed as shown in the original drawings (Figure 2-30), then over the past 60± years, the top layer of sacked concrete rip rap has been lost, followed by exposing of several inches of the unreinforced concrete encasement around the pipe. With time, more scour can be expected, and the hydraulic drop over the pipe encasement will eventually reach about 2 feet. This will result in an ongoing hydrostatic "push" of about 125 pounds per foot of pipe. As the pipe is segmented, and the encasement is unreinforced, with enough width the lateral force can be large enough to break open the pipe.

Figure 5-11. Matadero Creek crossing at Sta 33+43. View looking downstream (looking north)

At this location, we recommend that a short term mitigation be done to restore at least the original intent of the original design. This could be achieved by placing a reinforced concrete encasement around the existing encasement (capable of withstanding the full hydraulic forces), and placing some upstream and downstream scour protection. We also recommend that all other stream crossings be inspected annually, and similar repairs made should the concrete encasement be observed to be exposed.

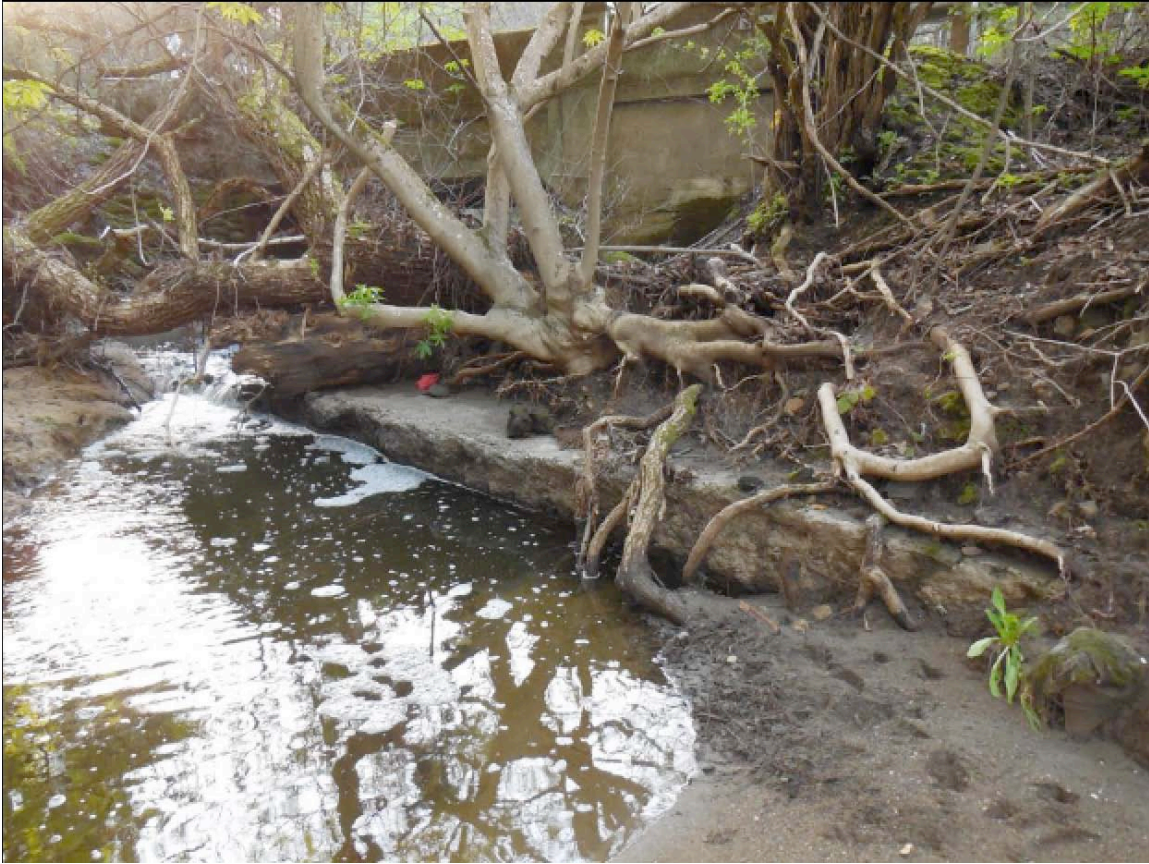
Figure 5-12. Matadero Creek crossing at Sta 33+43. View looking upstream (looking south). The exposed concrete encasement for the CCP is evident.

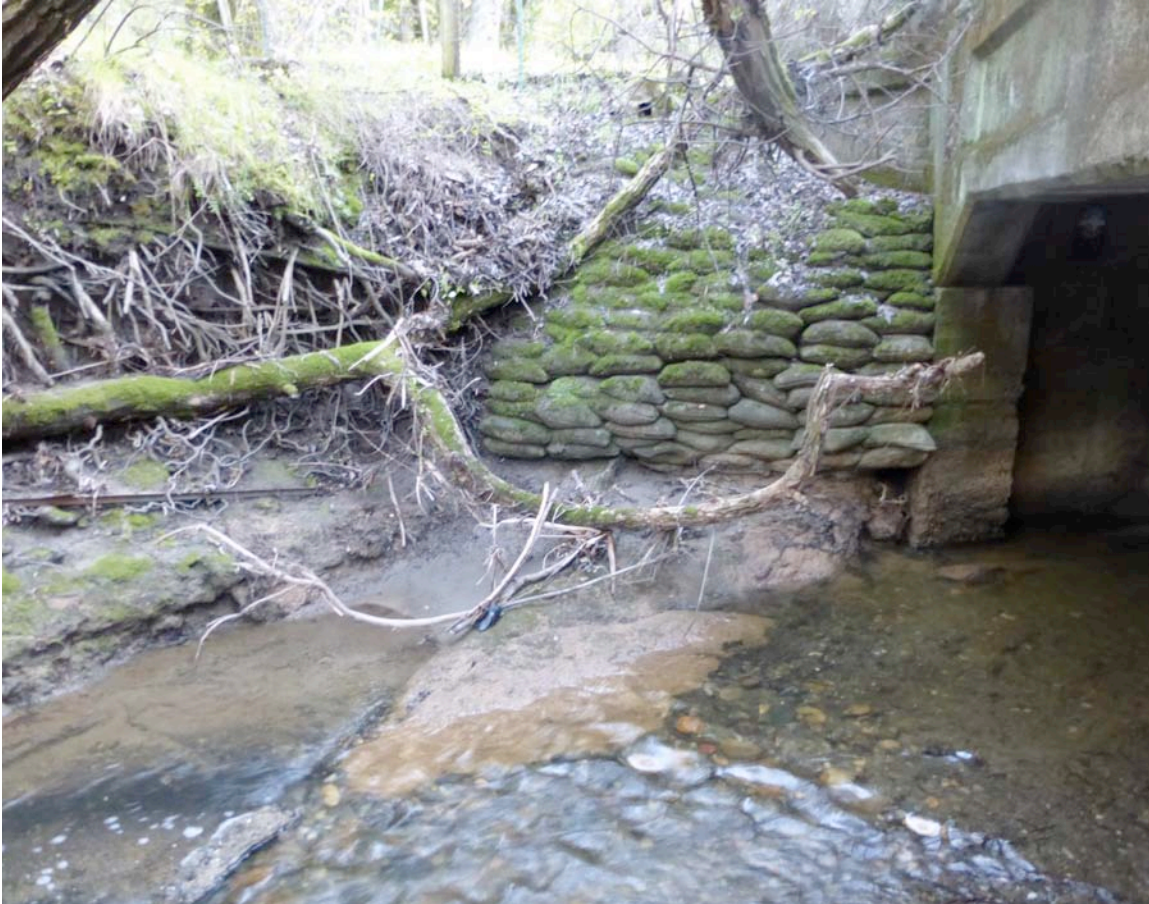
Figure 5-13. Matadero Creek crossing at Sta 33+43. View looking northerly. Slope rip rap is in place. Top of concrete-encased pipe is in foreground.

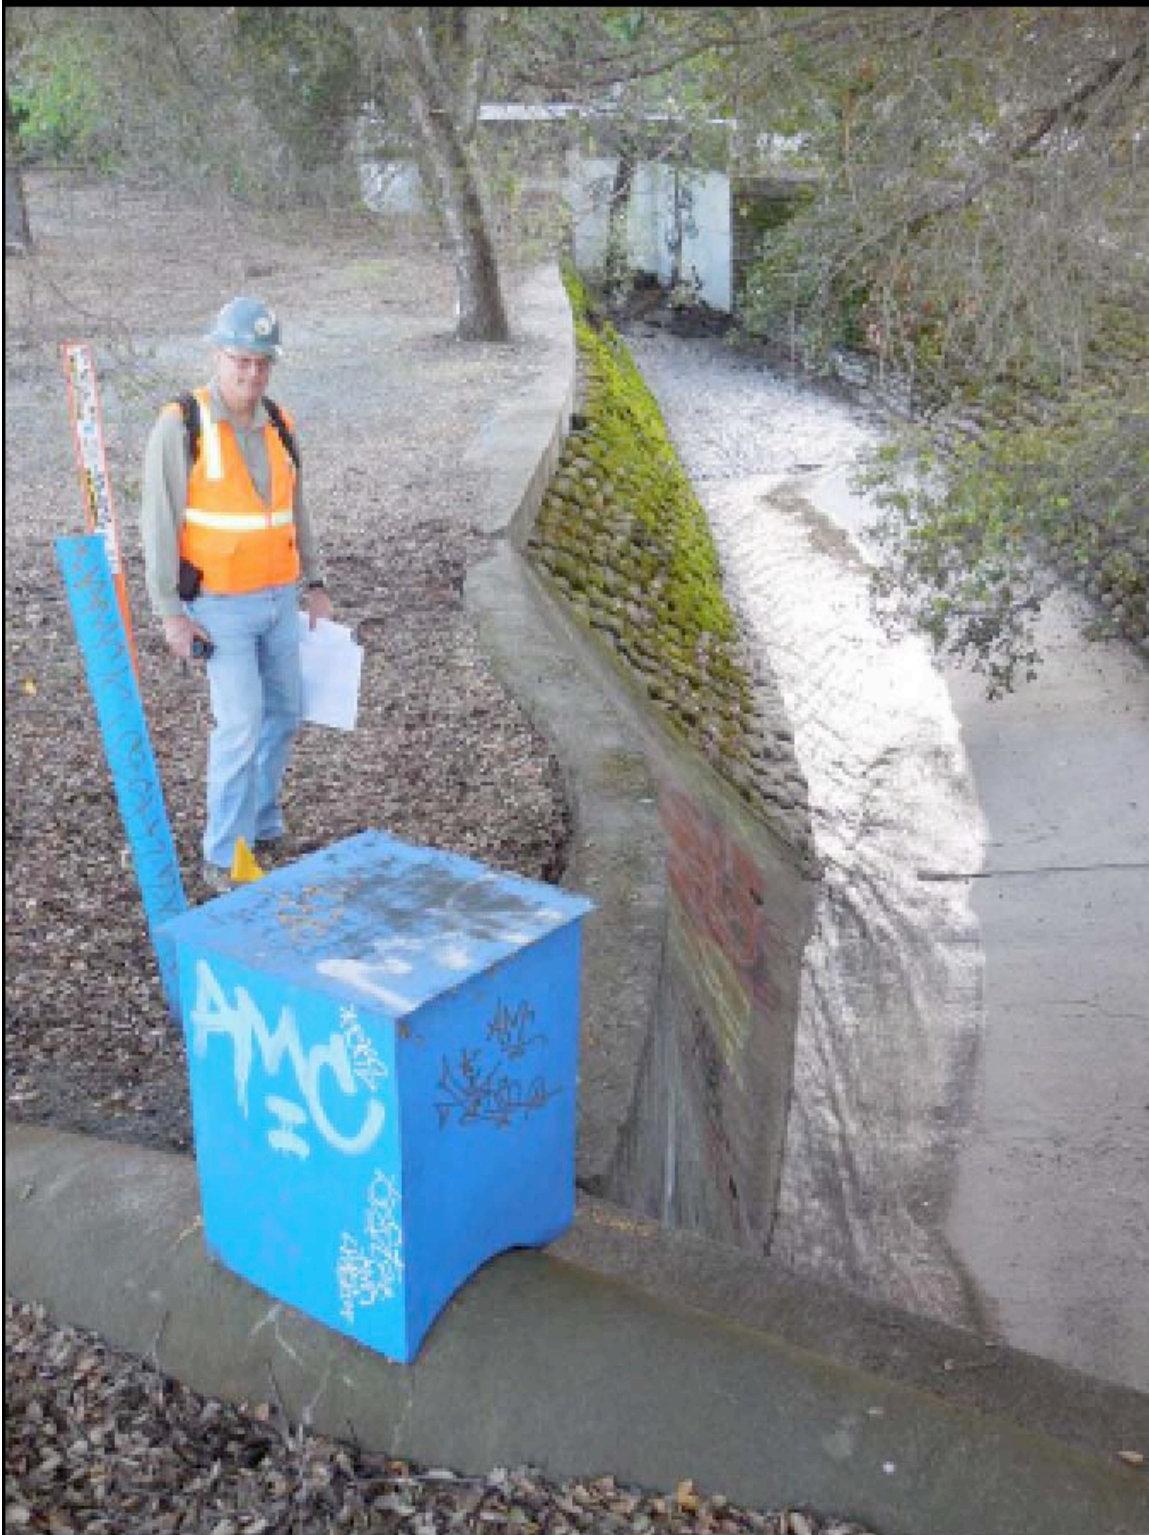
Little is known about the seismic design capability of the improved Matadero creek embankments seen in Figures 5-14 and 5-15.

- Small lateral spreads at the creek banks will impose high compression and bending on the pipe over-crossing of the creek, possibly leading to pipe failure. This could be mitigated (preliminary design strategy) by installing a new section of pipe over the creek, with the new section of pipe being designed to withstand any soil movement without failure, possibly by anchoring the pipe on drilled piers either side of the creek; and with adjacent buried pipe also able to sustain the soil movements.
- Other design solutions are also possible, including burying the water pipe under the creek; and/or soil improvements; and or adding an isolation valve / bypass capability.
- All these solutions suggest that design effort include the following: collection of design and construction records of the creek embankments (possibly Palo Alto

Summary. The potential for differential ground movement adjacent to the stream channel is considered high during design level ground motions. A preliminary cost, considering the preliminary design strategy above, is included in this report.

Figure 5-14. Matadero Creek adjacent to Quarry Booster Pump Station. View looking upstream (looking south). Pipe in foreground is inlet water pipe to Quarry booster pump station. Eidinger stands behind box presumed to house an air release valve.

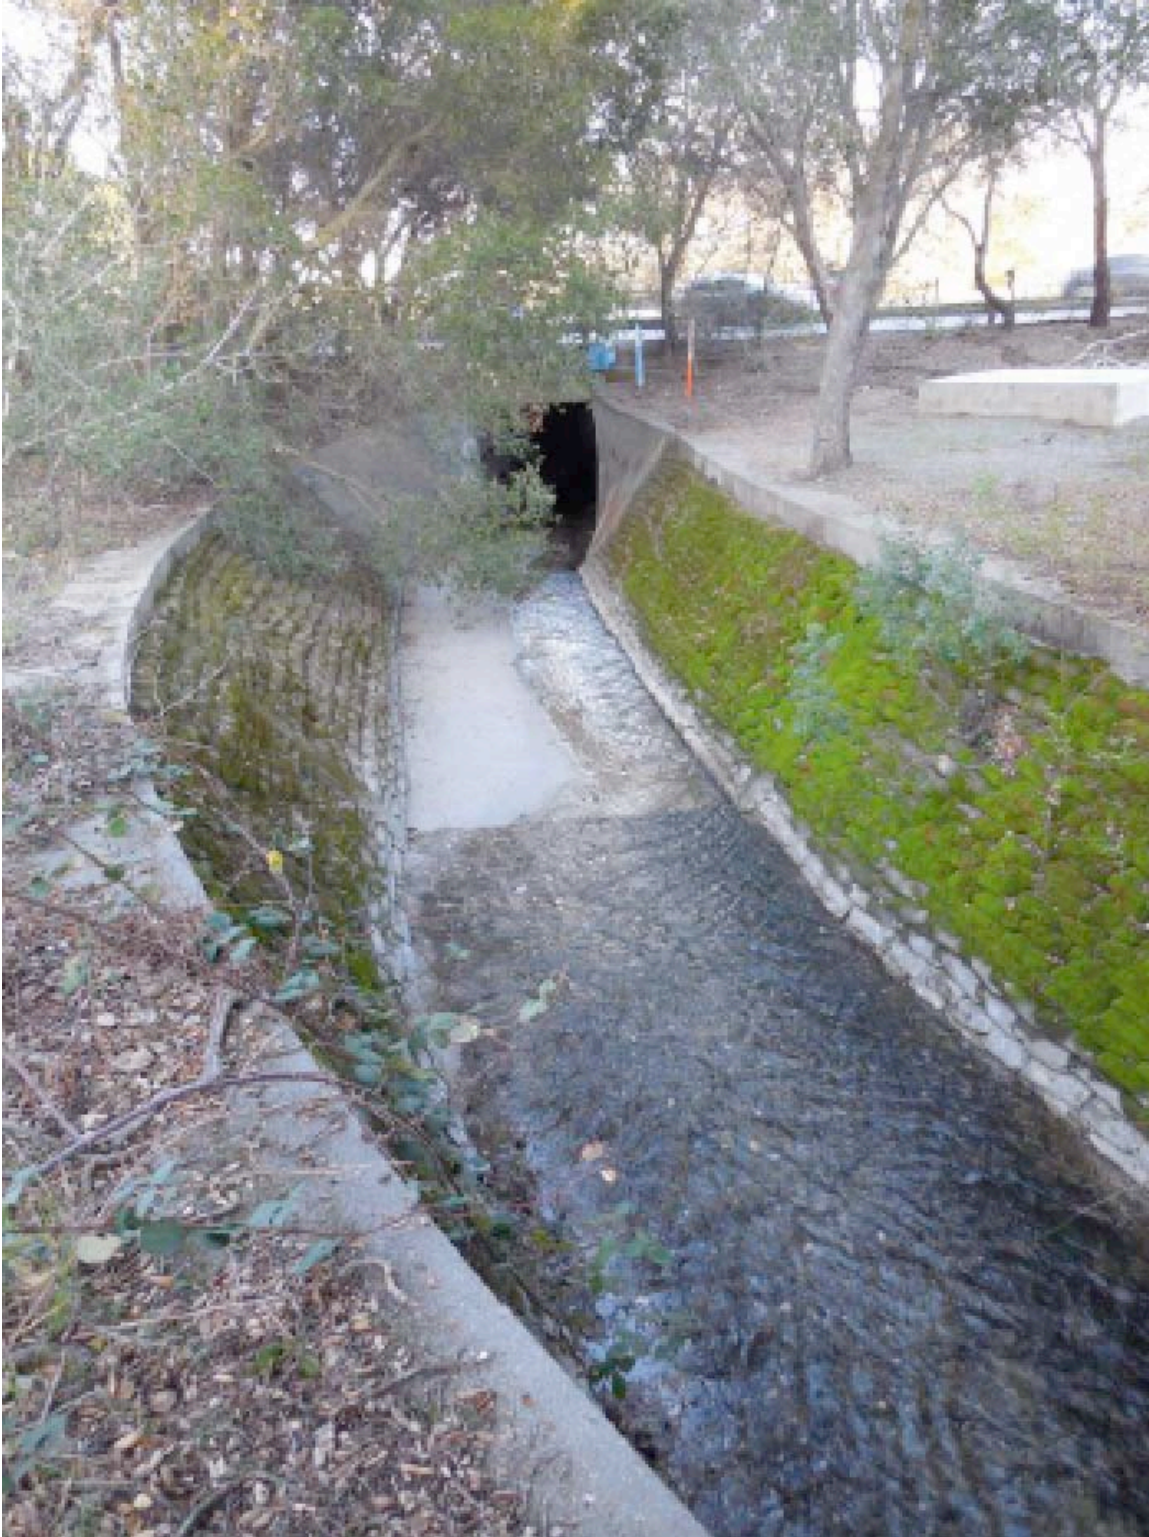
Figure 5-15. Matadero Creek adjacent to Quarry Booster Pump Station. View looking downstream (looking north). Quarry Booster pump station is to right of the photo.
