City of Palo Alto Water System Pipe Replacement

*Prepared for:
City of Palo Alto*

*G&E Engineering Systems Inc.
6315 Swainland Rd
Oakland, CA 94611
(510) 595-9453 eidinger@geEngineeringSystems.com*

*G&E Report 119.01.02, Revision 0
July 21, 2015*

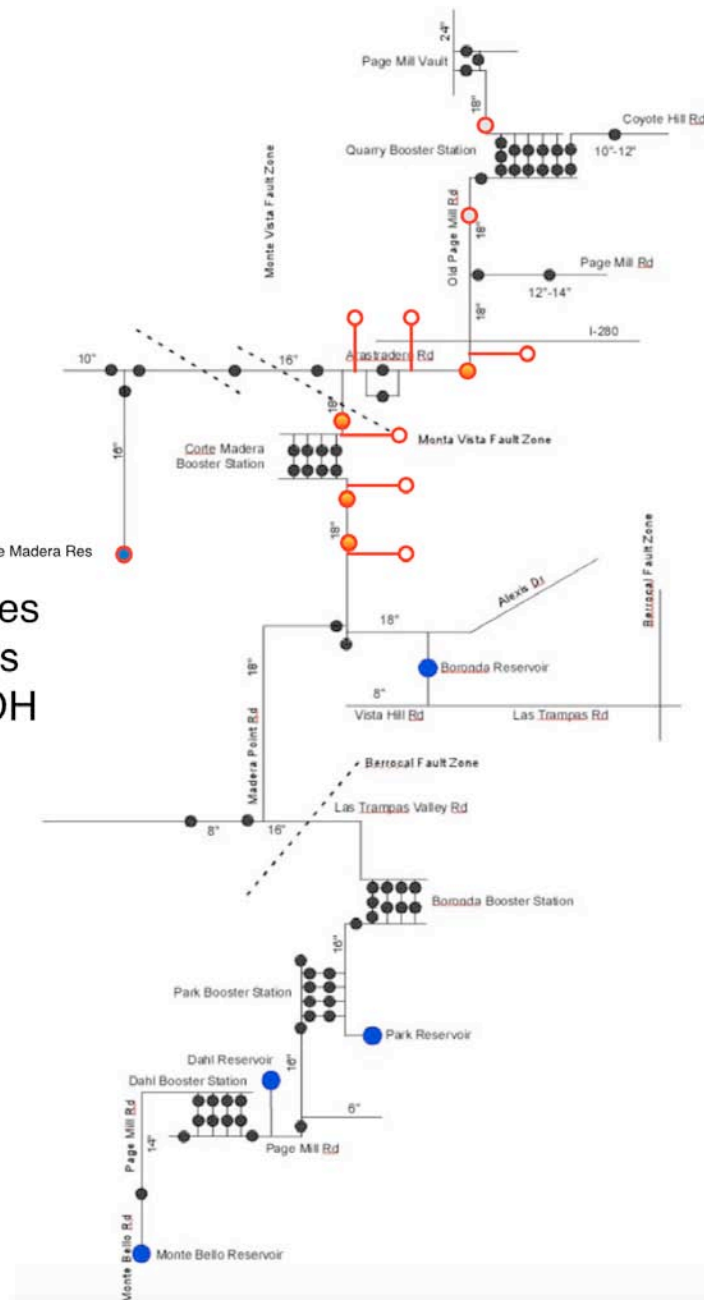
Figure 5-19. Recommended Upgrades for Foothill Pipe Network

- The limiting factors in using the ULDH are as follows: assuming a flow rate of about 2,000 gpm, a 12" ULDH is practical over 2,000 feet or so. That means that isolation valves and suitable outlet manifolds would need to be placed ideally no more than about every 2,000 feet along the pipe. The existing pipe is about 24,000 feet long from Quarry Booster to Monte Bello Reservoir. Figure 5-18 shows that there are already about 10 such valves (with each pump station / reservoir set as being 1 effective valve). The preliminary locations for extra valves and outlets are shown schematically in Figure 5-19:

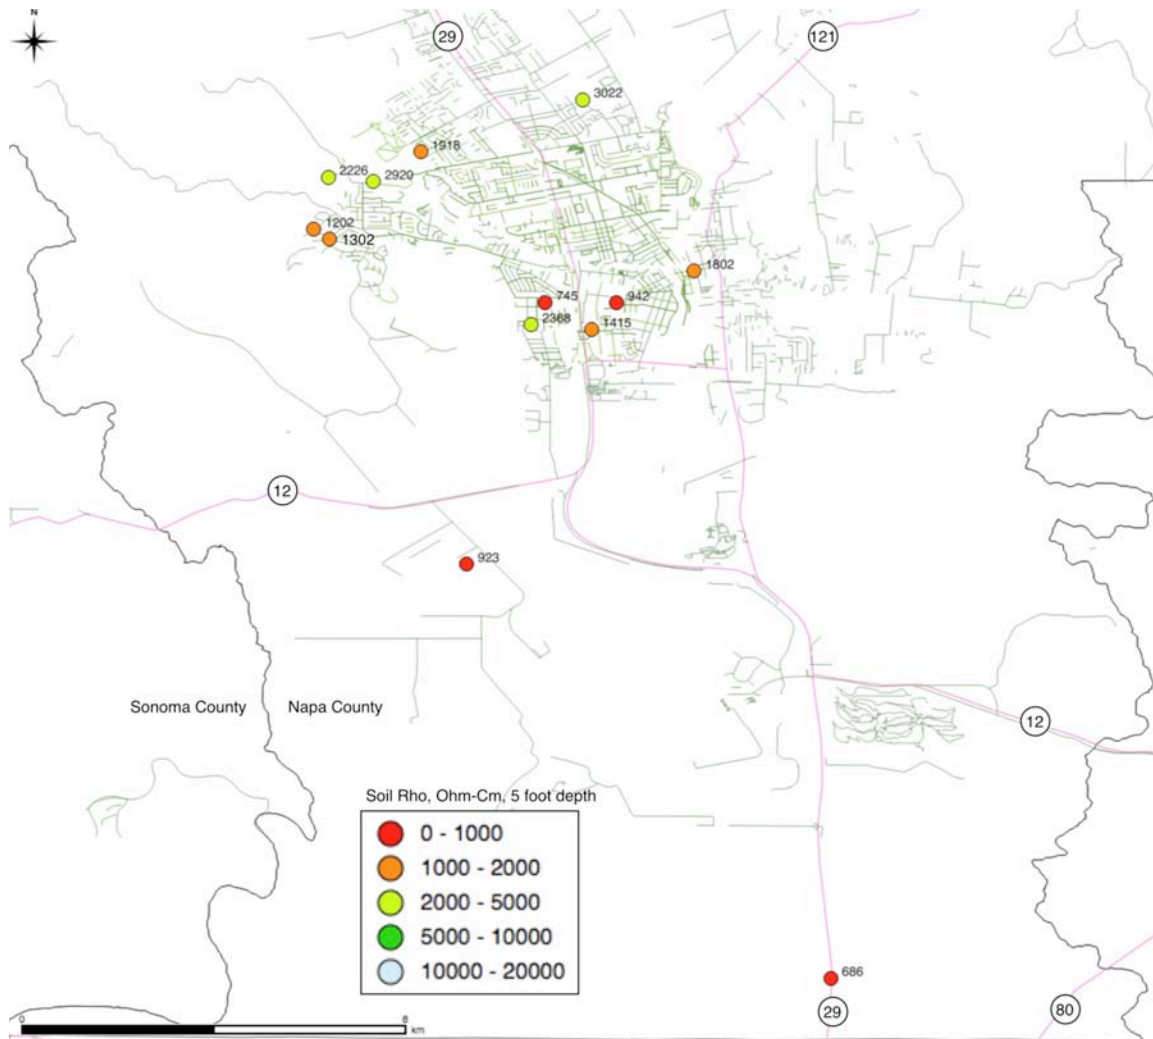
Figure B-14. Soil Resistivity and Location of Pipe Repairs for Napa Water Pipe

Figure B-14 shows the same information, along with results from soil resistivity (Rho) tests of the same type as performed in the City of Palo Alto. Each Rho test is color coded, and the actual test value is shown next to the symbol.

Figure B-14 shows that the soils in Napa are extremely aggressive. This may be in part due to the volcanic origins of the soils; many are clayey-in nature. At three test locations, Rho was under 1,000 ohm-cm (extremely corrosive); four more tests showed Rho from 1,000 to 2,000 ohm-cm (very aggressive); and four more tests showed Rho from 2,000 to 3,022 ohm-cm.

The Napa water department reports that their ductile iron pipe has had a fairly high leak rate, even without the earthquake, and this reflects that Napa apparently did not install polyethylene "baggies" over the ductile iron pipe; the very aggressive nature of the soils; coupled with the relatively thinner wall thickness of ductile iron pipe (under 0.2 inches) relative older but thicker cast iron pipe (commonly 0.5 inches or thicker).

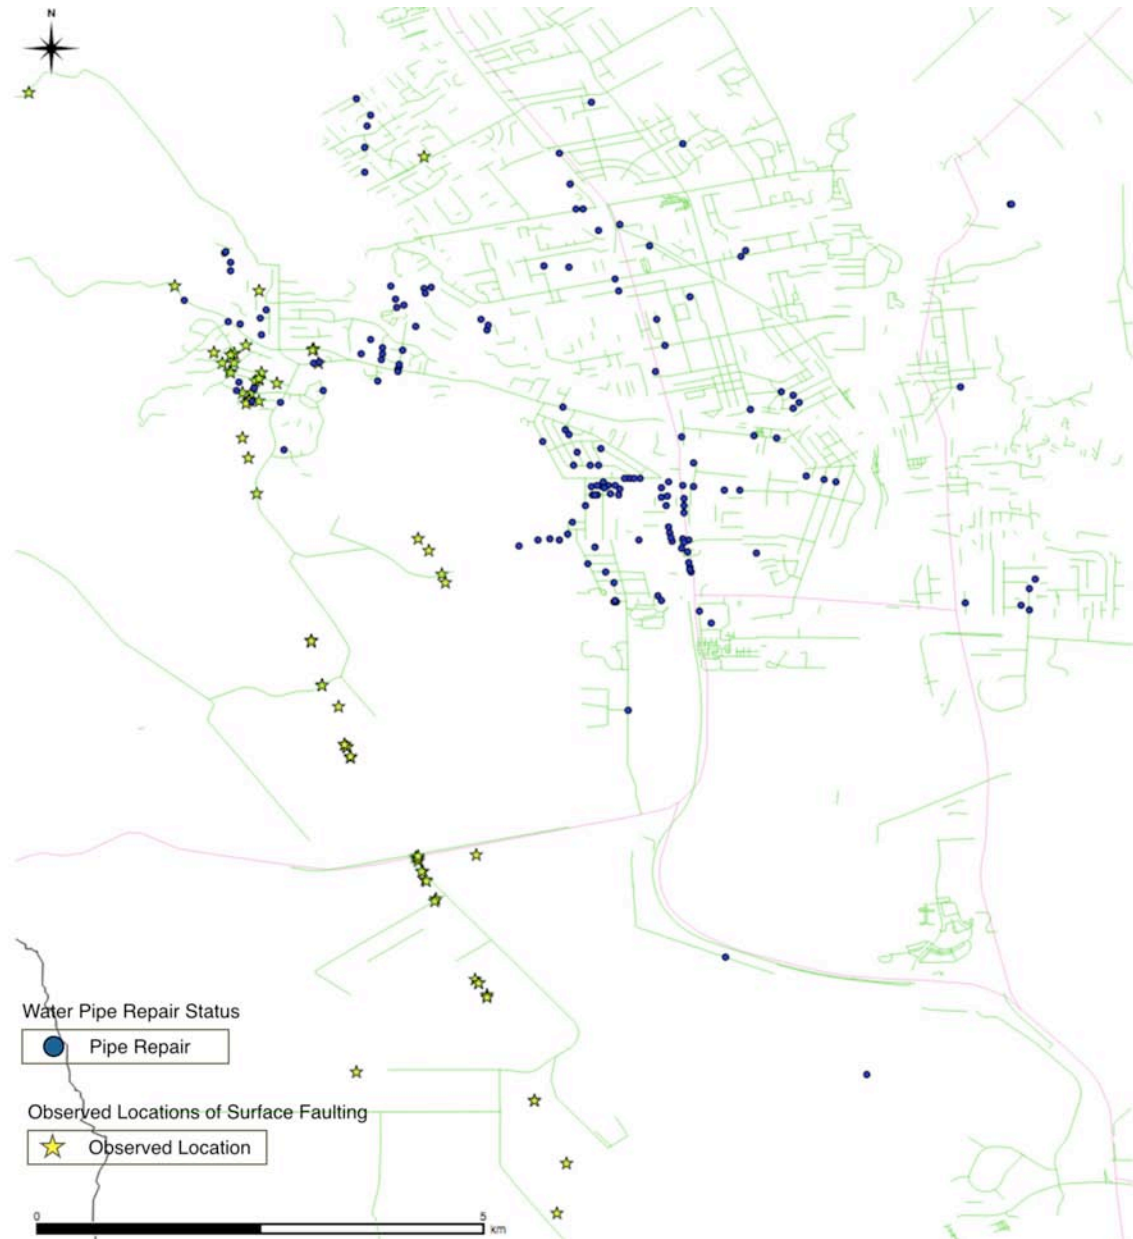
Figure B-15. Location of Surface Faulting and Water Pipe Repairs

In the northwest part of the water system, there was surface faulting. Figure B-15 shows a map of the 71 locations with observed surface faulting (yellow stars), along with the pipe repair locations. The light green lines indicate streets; light blue lines indicate major roads / highways.

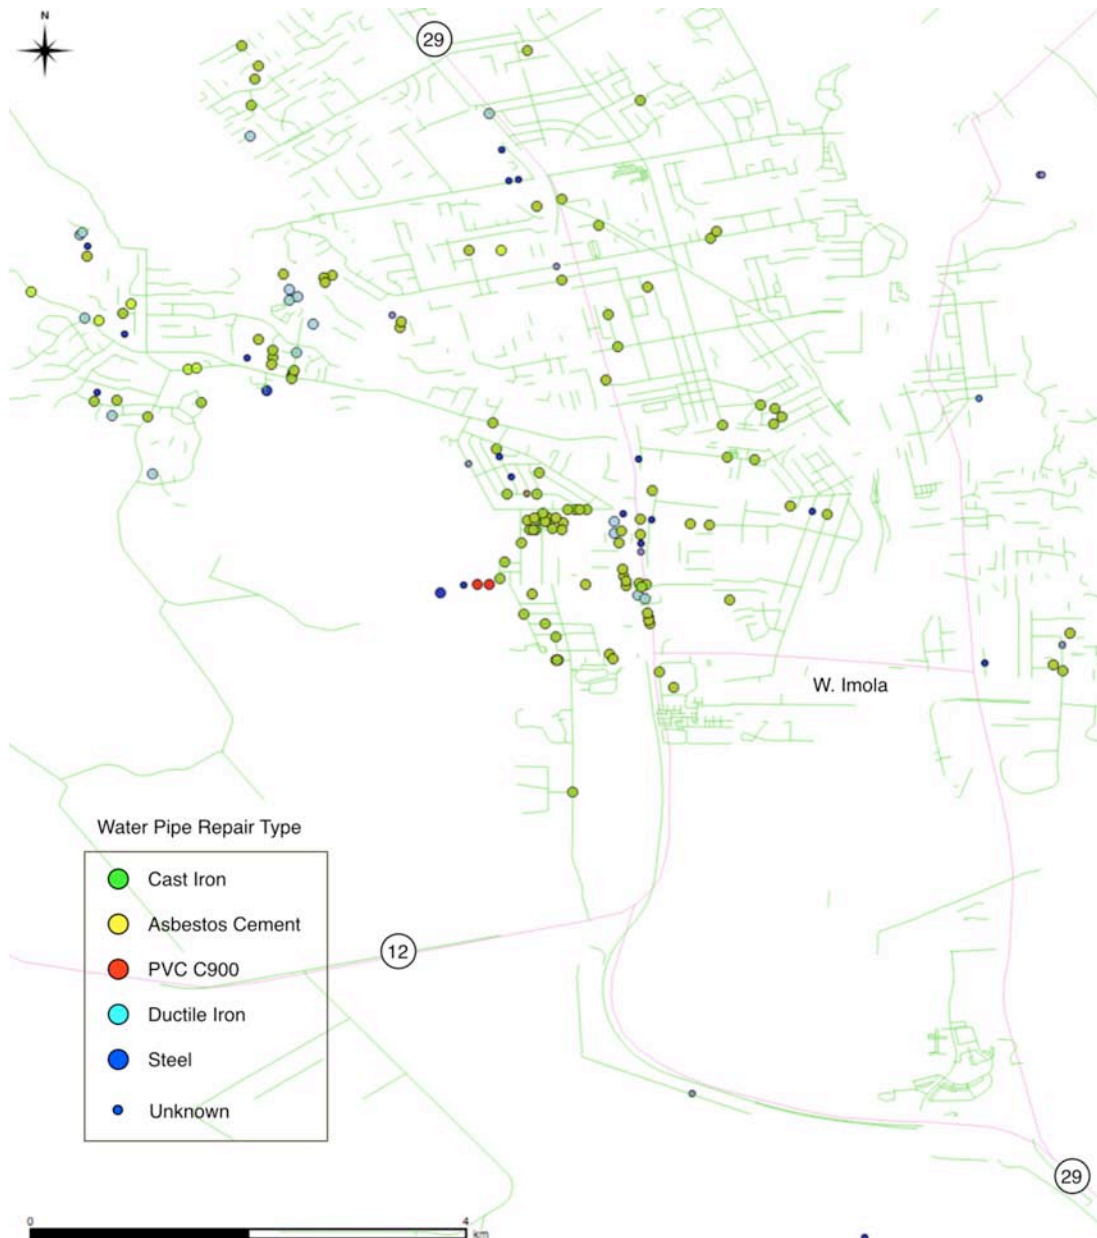
Figure B-16. Water Pipe Repairs – By Material

Figure B-16 shows the location of pipe repairs, with the pipe main material indicated by color. Most repairs were to cast iron pipe (green dots) followed by ductile iron pipe (light blue dots).

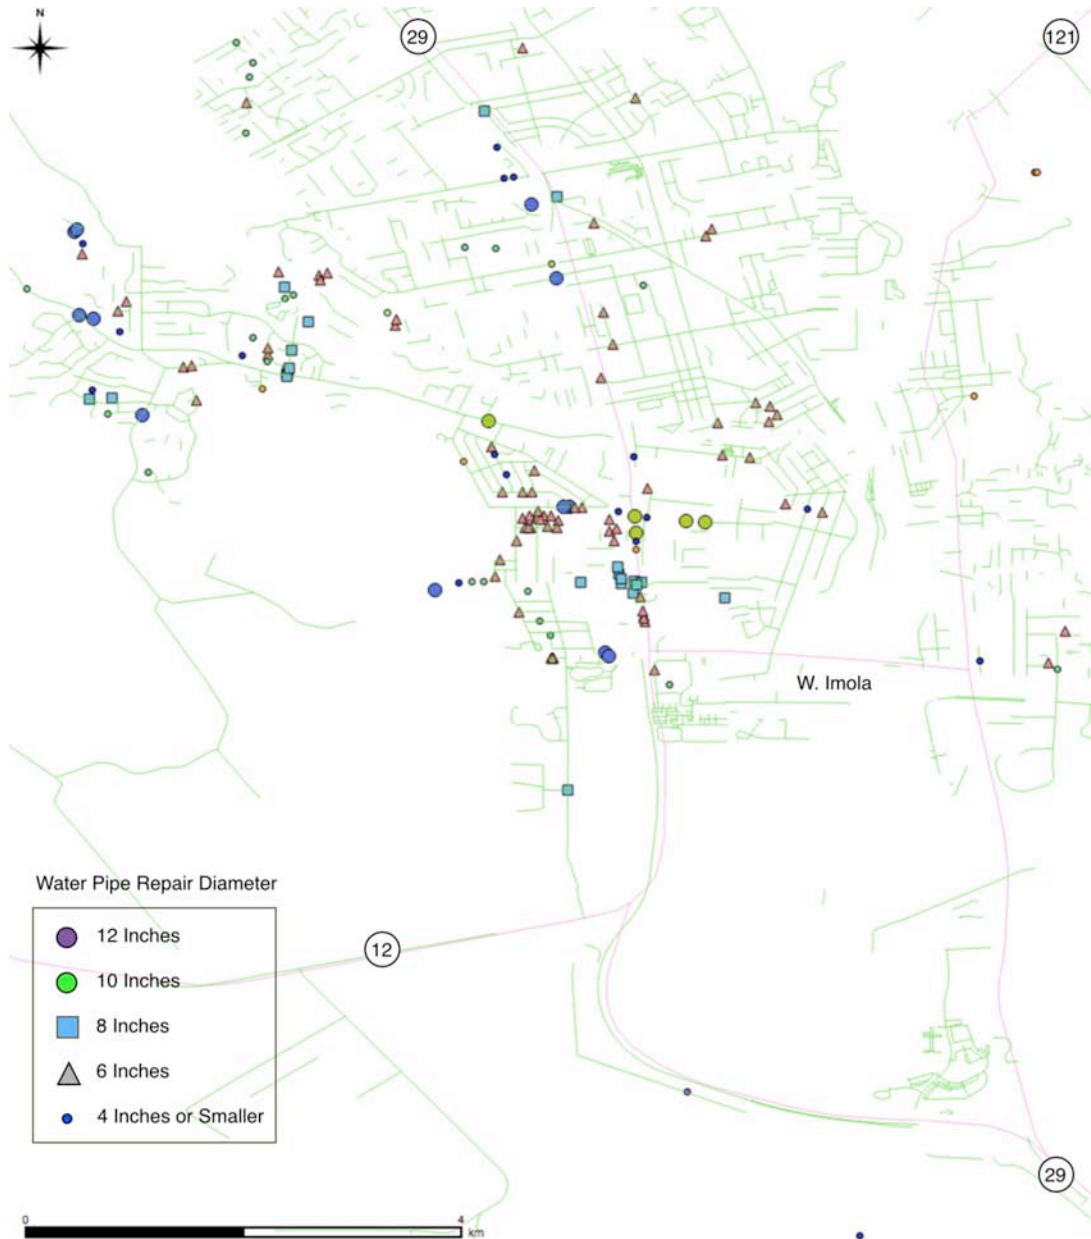
Figure B-17. Water Pipe Repairs – By Diameter

Figure B-17 shows the location of pipe repairs by diameter. The largest pipe repair made in the two weeks following the earthquake was 12-inches. In the 4 months afterward, a 36-inch diameter AC transmission pipe broke 3 times; that pipe ran north-south along the west side of Napa, as seen in Figure B-12.

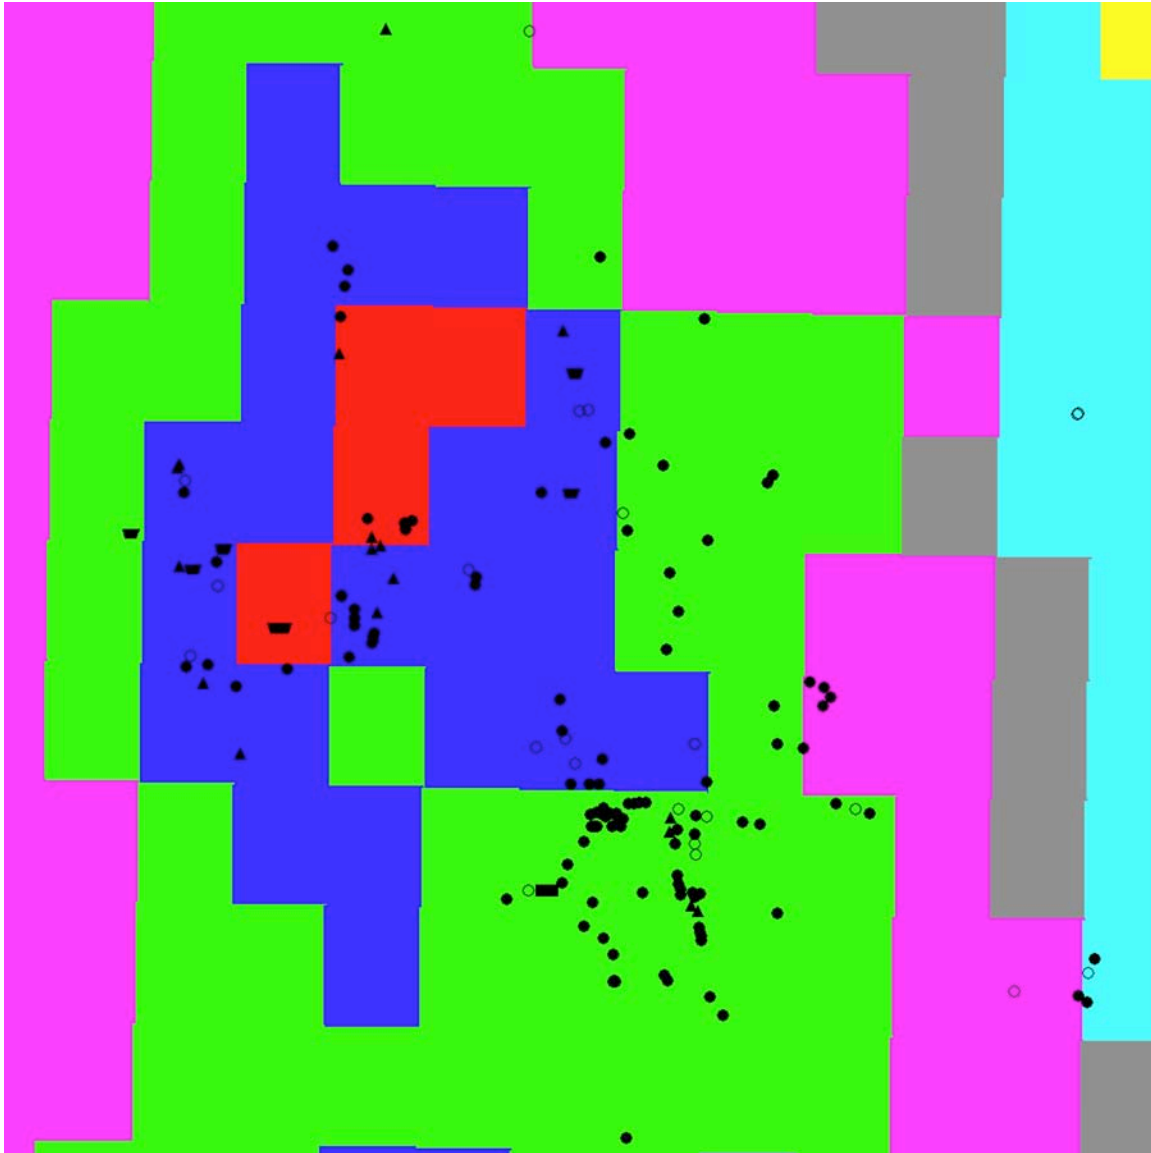
Figure B-18. ShakeMap PGVs (Maximum of NS, EW)

Figure B-18 shows the PGV map for the Napa area. This map shows the maximum of NS or EW PGV, based on the USGS ShakeMap. Each "box" represents an area of about 0.8 km (east-west) by 1 km (north-south). The symbols are at the locations of the pipe repairs as shown in Figure B-18: solid dot: cast iron; triangle: ductile iron; open dot = unknown; polygon: asbestos cement; square: PVC (C900).

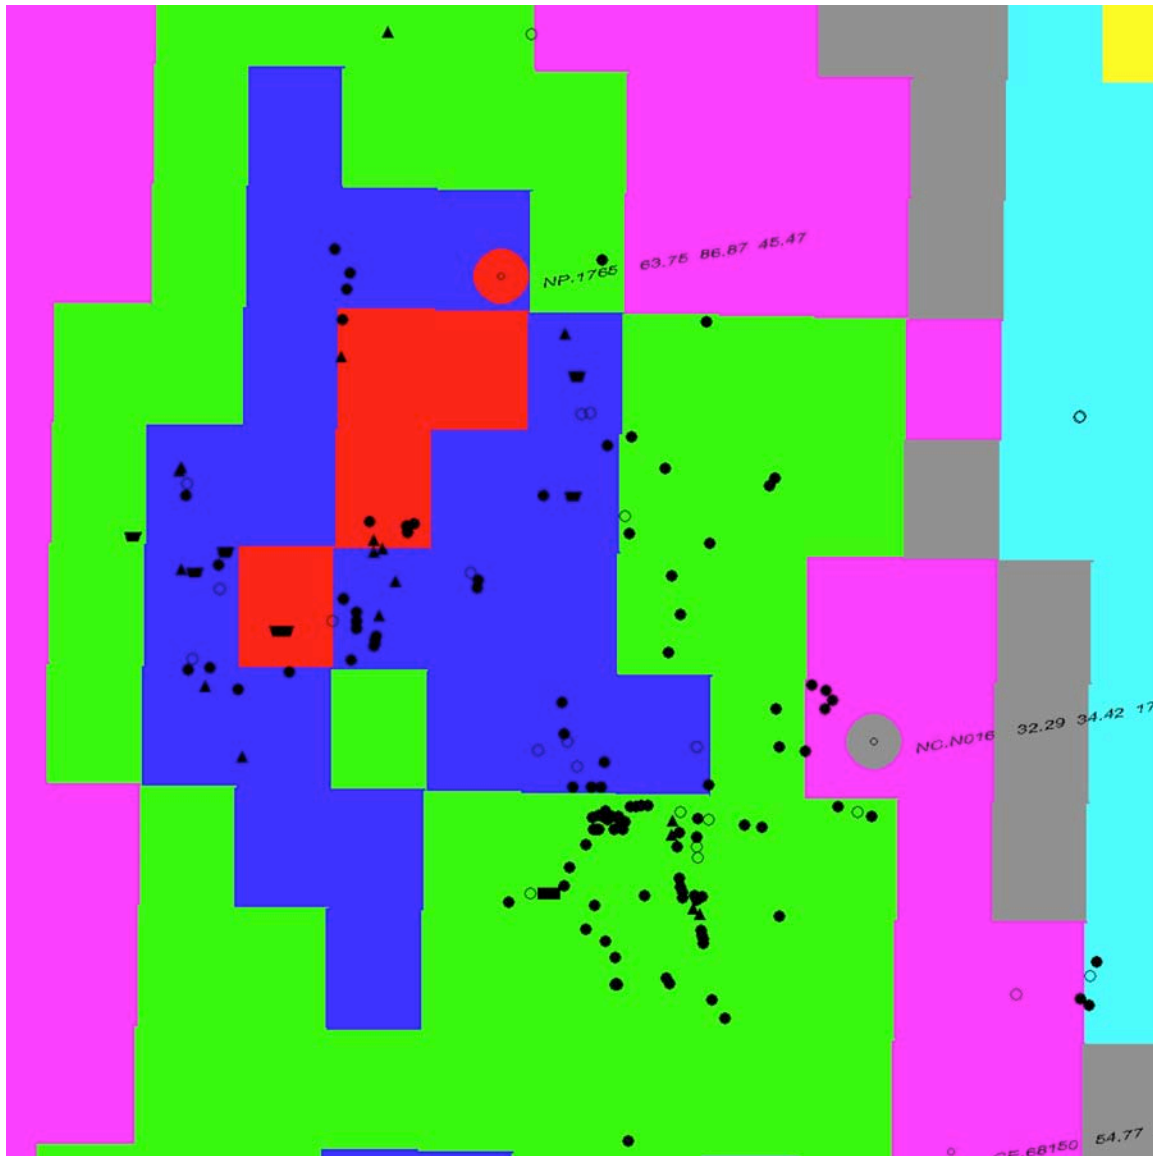
Figure B-19. ShakeMap PGVs and Instrument Locations (Dots)

To help appreciate the uncertainty in Figure B-18, there were only 3 instruments in the strong ground shaking area (PGV >20 cm/sec) entire area, shown in Figure B-19.

- Instrument NP.1765. Located inside Fire Station 3 at the north end of Napa. PGV recordings were 64, 87, 45 cm/sec in the NS, EW and vertical directions, respectively.
- Instrument NC.N016. Located near downtown Napa. PGV recordings were 32, 34, 17 cm/sec in the NS, EW and vertical directions, respectively.
- Instrument CE.68150.N016. Located south of Napa (and just off the south end of the map). PGV recordings were 55, 41, 15 cm/sec in the NS, EW and vertical directions, respectively.

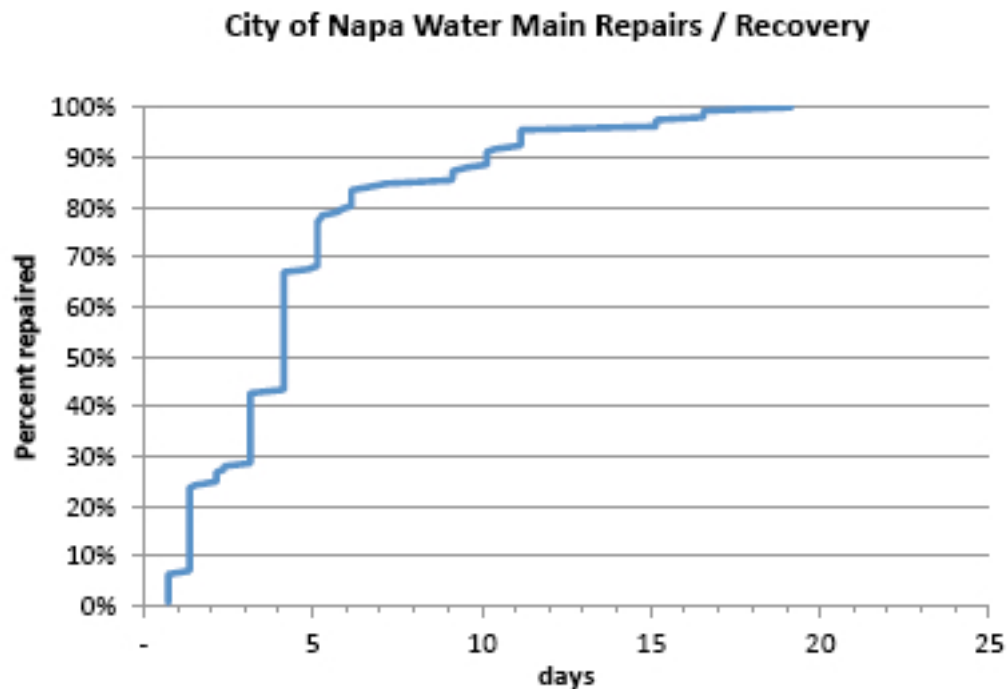
Figure B-20. Napa Water Recovery

Figure B-20 shows the restoration of water service after the earthquake.

All crews arrived with spare parts, trucks and equipment, typically 5 people per crew. All mutual aid crews were released by August 29 2014 (note the slow down in the rate of pipe repairs after Day 5, Figure B-20). It was initially thought that the mutual aid crews were sufficient to effect nearly all the pipe repairs by August 29; however, over time, as the last pipe repairs were made, additional pipe leaks were identified as repaired pipes were re-pressurized.

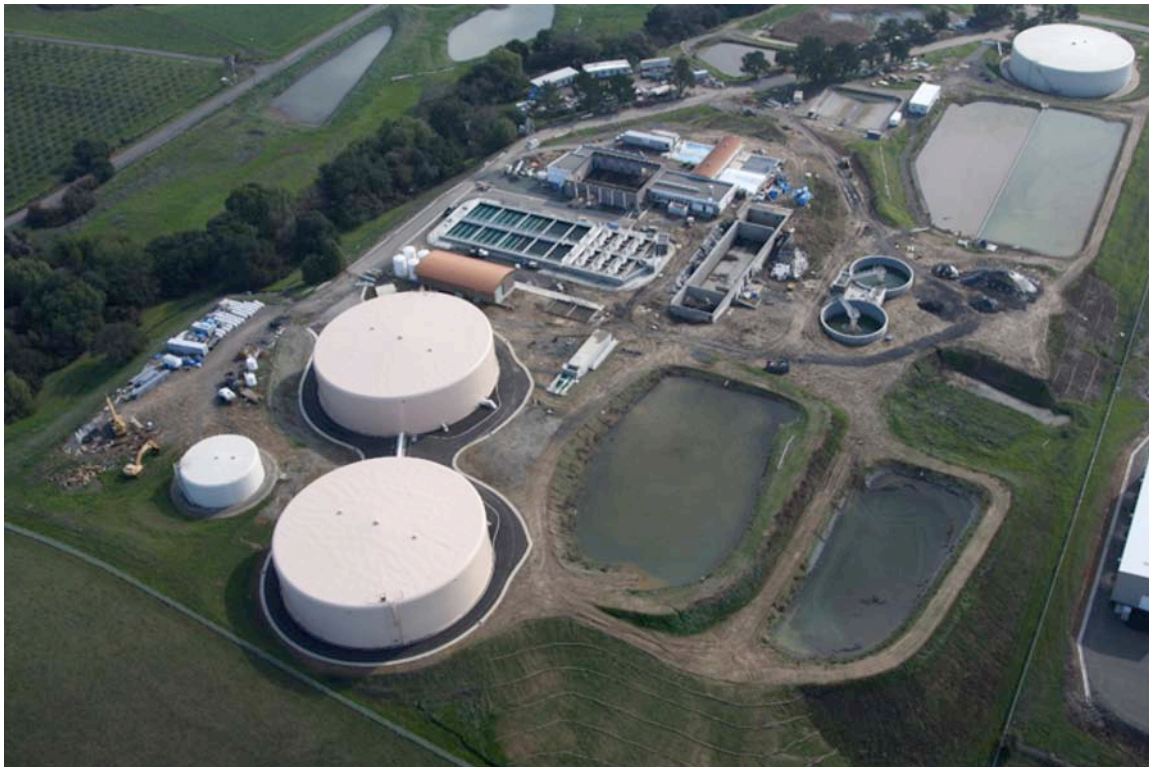
Figure B-22. Jamieson WTP, Aerial View, Looking South

There was no damage at this WTP. DWR reports no damage to the North Bay Aqueduct (ground motions typically PGA = 0.05g to 0.15g).

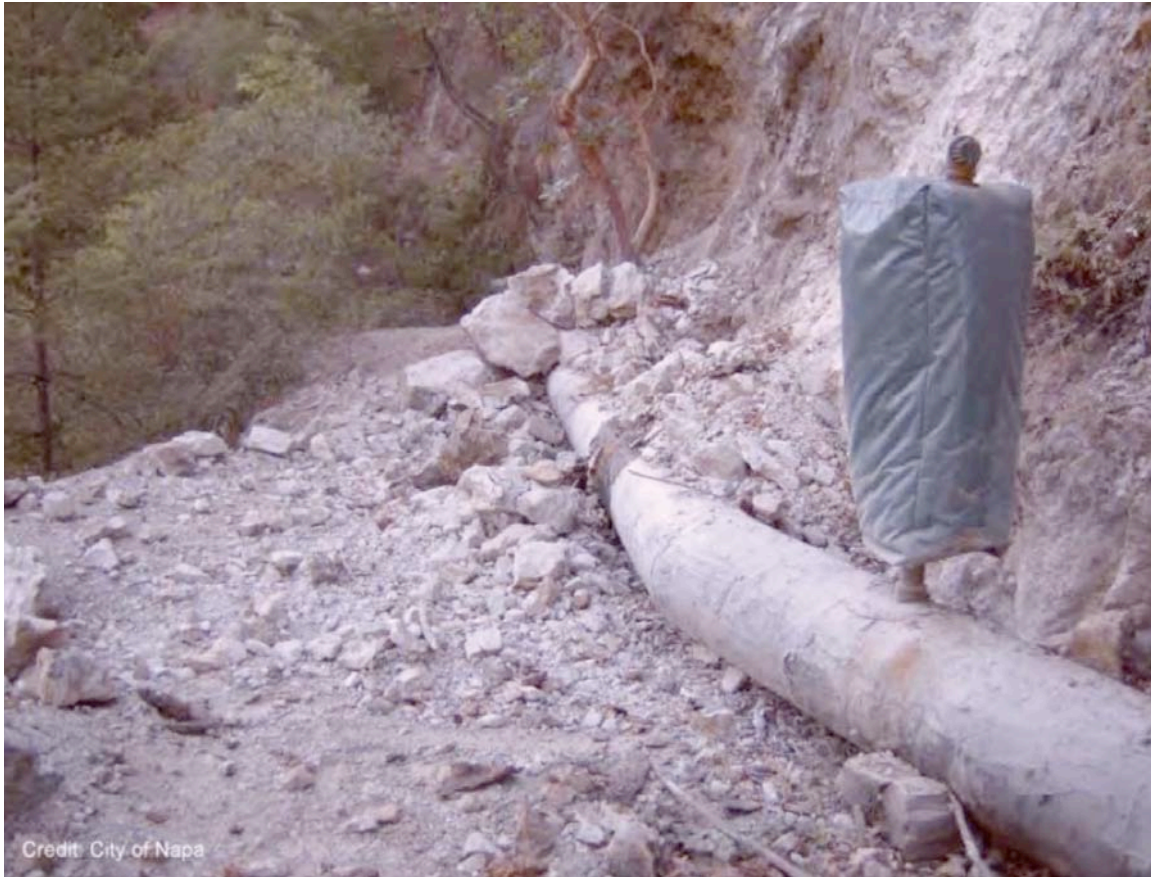
Figure B-24. Milliken Pipeline with Rockfall

The Milliken WTP was built in 1975. Figure B-23 shows a rockfall atop the 16" raw water pipeline to the Milliken WTP; the pipe was thought not to be damaged.

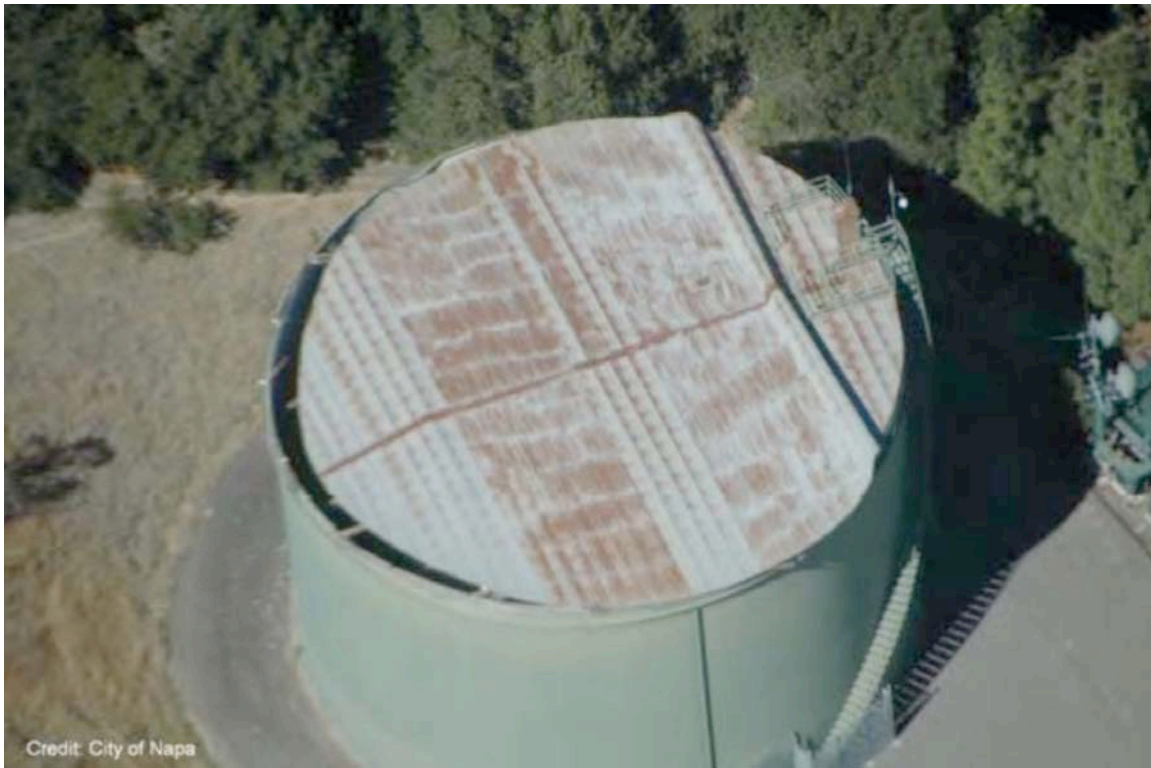
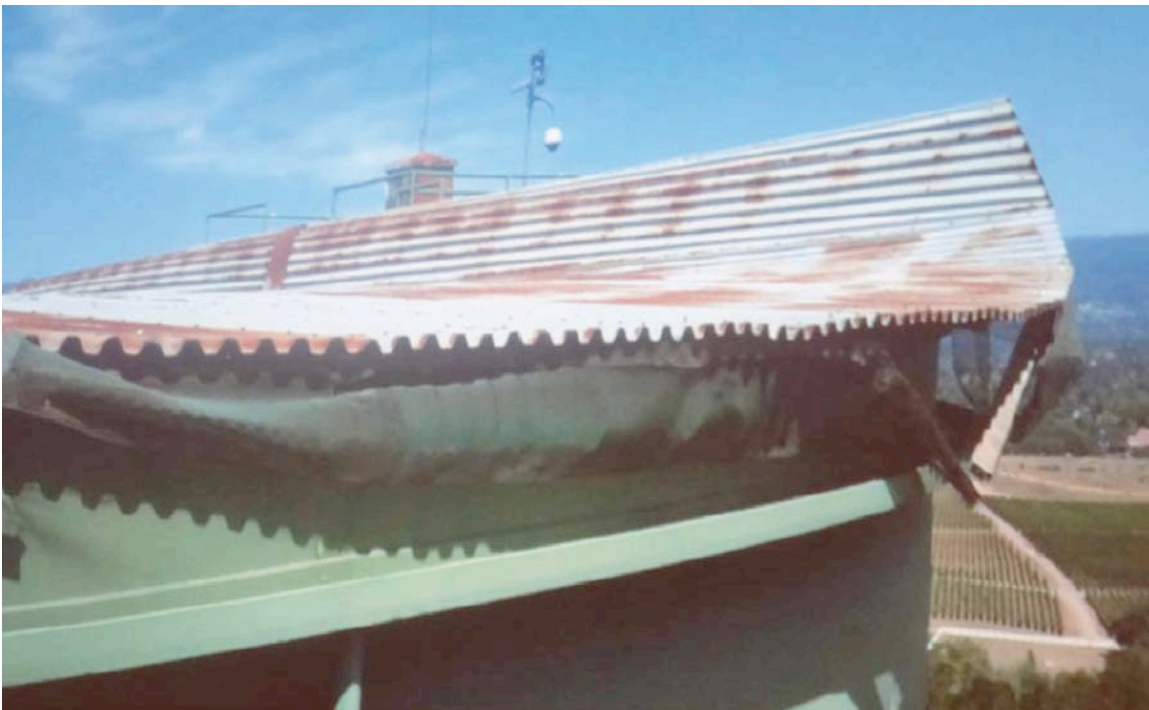
Figures B-25 and B-26 show the damage to the corrugated metal roof for Tank B.

Figure B-25. Tank B. Damaged Corrugated Metal Roof

Figure B-26. Tank B. Corrugated Metal Roof Damage (Side View)

During the earthquake, the tank water depth was at 31.5 feet, with overflow at about 37.5 feet. The partially-filled tank likely rocked, with the tank walls uplifting. The unrestricted water slosh height would have been perhaps 3 to 5 feet (this presumes a certain level of shaking, which in reality is unknown), but with the tank water elevation at about 6 to 7 feet beneath the wood timbers and rafters, there might have been no major high-pressure water impacts from the sloshing into the roof system; all the same, the adjacent Verizon telecom building that is located at the water tank site, just below the tank, did show some evidence of water inundation, suggesting that the water slosh height was at least enough to have water spill through the ventilation screens near the top of the tank; so this suggests that the actual water slosh height was more than 5 feet. The uplifting of the walls would have tried to lift the wood beams upwards, and as they were not designed for this movement, they were damaged, possibly falling sideways, and then shifting the corrugated metal roof sideways, as seen in Figures B-25 and B-26. There was no evidence of steel shell buckling at the base of the tank.

Subsequent to the earthquake, Napa replaced the original corrugated roof system on this tank with an aluminum-dome type system.

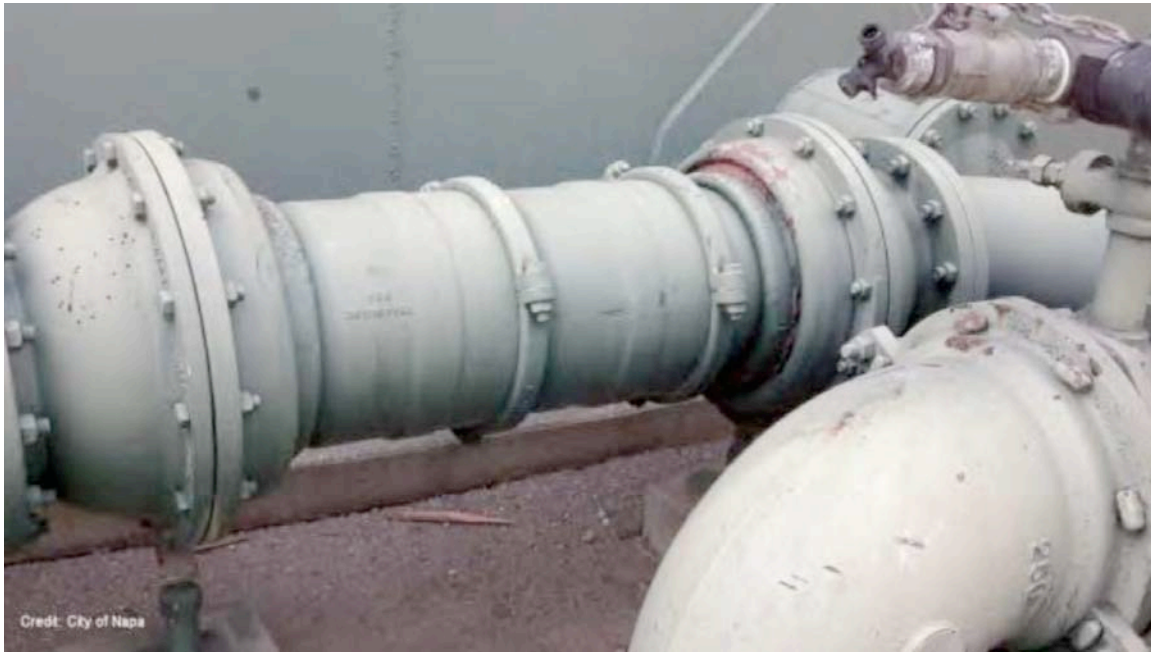
Figure B-27. Tank B. Inlet Outlet Pipes, Pipe with Ball and Slip Joints

Prior to the earthquake, the inlet-outlet pipes had been retrofitted with EBAA-type ball-and-slip joints, Figure B-27.

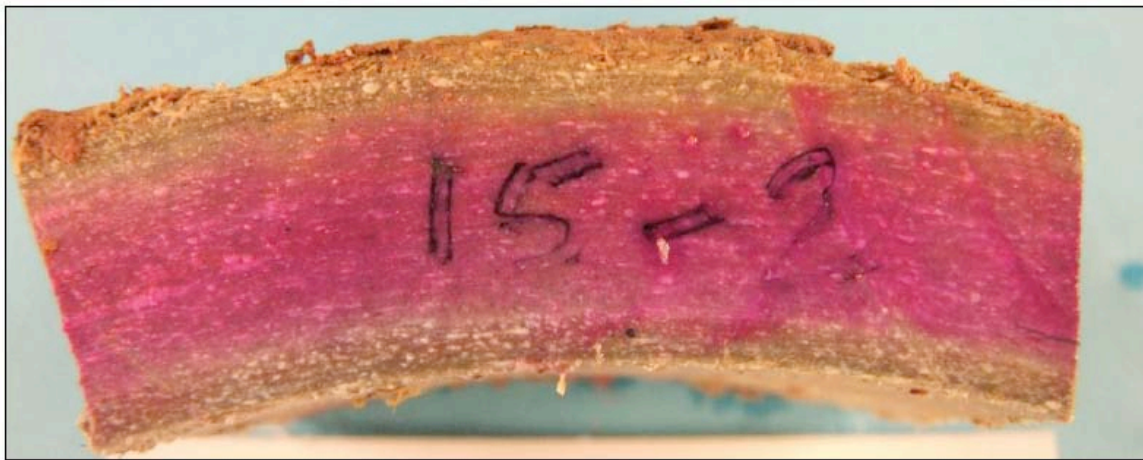
Figure C-1. Results of Stain Test, EBMUD AC pipe

Figure C-1 shows a sample AC pipe phenolphthalein test. The image shows a cross section of pipe. The pinkish center band shows high pH, while the inner and outer layers did not stain pinkish, suggesting zones which are acidic, and indicating that leaching or corrosion has occurred.
